MANAGEMENT MODEL FOR CONSERVATION CONDITIONS OF INFRASTRUCTURE AT UNIVERSITY USING GEOGRAPHICAL INFORMATION SYSTEM

Abstract: Public or private built heritage requires the conservation of infrastructure, and it is up to the responsible managers to survey, analyze and make decisions for the maintenance of heritage conservation. The Geographic Information System (GIS) presents itself as a tool to support decision-making by management bodies as it enables the visualization, analysis, correlation and integration of data and information in a geospatial environment. In this study, it is proposed to present the model elaborated for the investigation of the conservation of infrastructure of didactic environments at the State University of Maringá, Pr, using GIS environment. The main campus of the State University of Maringá was used as an area for applying the model. This article addresses only the investigations carried out for classrooms and didactic secretariats. As an investigative tool, a checklist was drawn up, with indications of the presence or absence, quantity and conservation conditions of infrastructure due to pathological manifestations (painting, mold, efflorescence, spalling

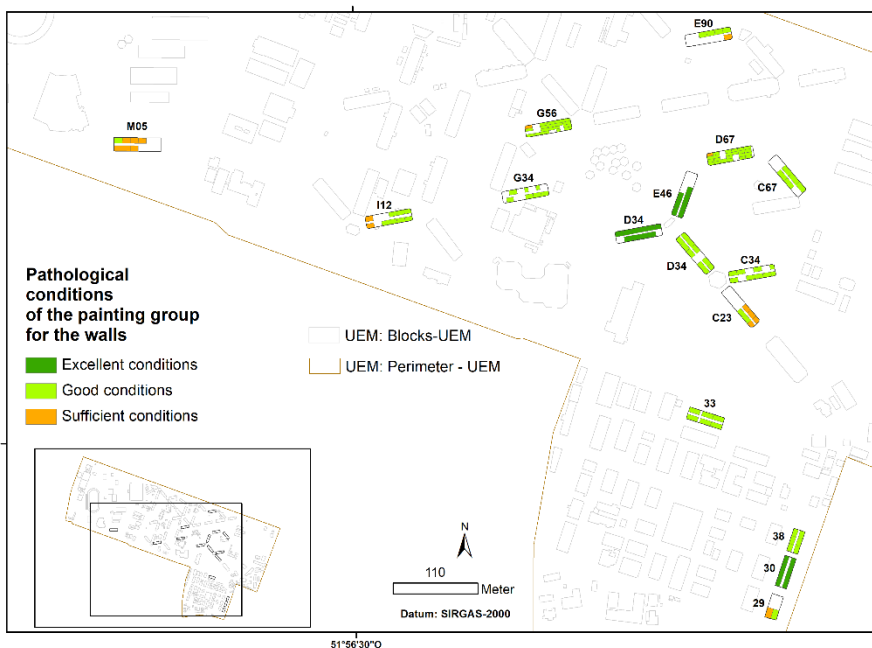
It can be observed that, for the painting of the walls, there was a pattern of approximation depending on the rooms contained in the same block for the same conditions. It was observed that Blocks D34, E46 and 30 presented excellent conditions regarding the painting of the walls, in all didactic rooms. In contrast, Block M05 and C23 presented more than 60% of the rooms in sufficient conditions, *i.e.*, painting the entire wall, but with cracks and dirt. For ceiling painting, the pattern of rooms contained in the same block having most rooms in the same conditions is noticeable, however, for ceiling painting, only Block 30 presented excellent conditions in all its rooms. The blocks with most rooms in sufficient conditions for ceiling painting were G56 and D67.

Figure 3. Pathological conditions of the painting group of the classrooms for the walls.

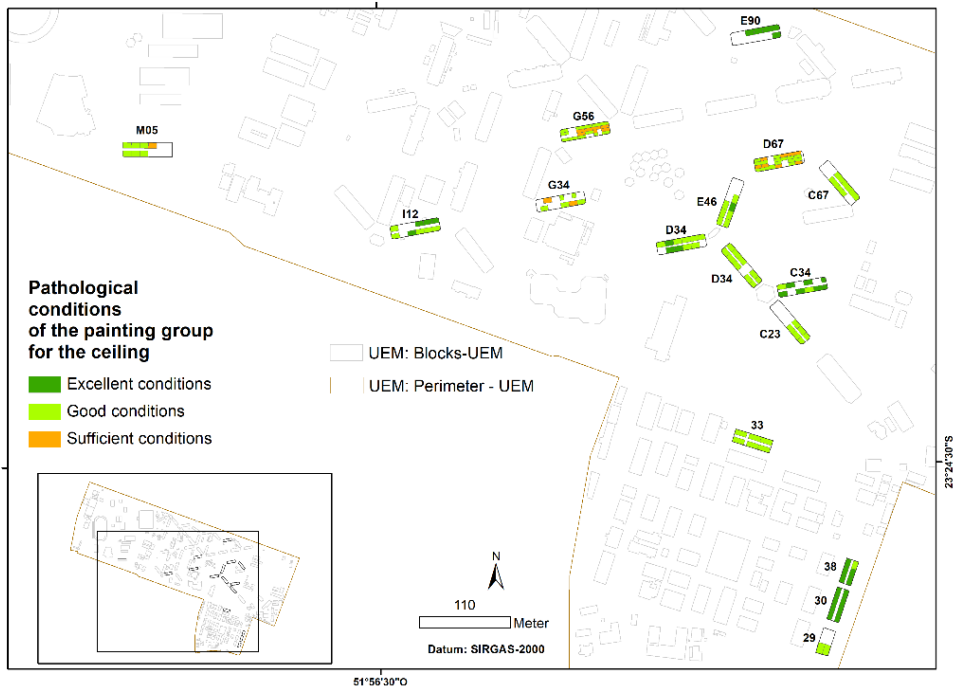
Figure 4. Pathological conditions of the painting group of the classrooms for the ceiling.

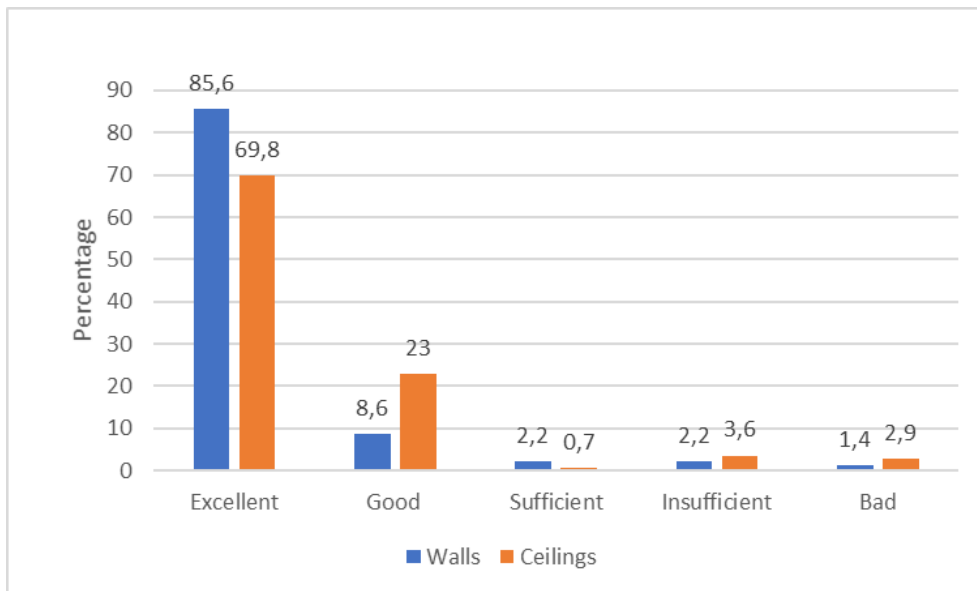
As for the verification of the group (efflorescence, mold and spalling), for both walls and ceilings, it can be observed that more than 85% of the walls and more than 65% of the ceilings are in excellent conditions, with no pathology), as can be seen in the Graph of Figure 5.

Figure 5. Percentage of the pathological conditions of the classrooms regarding to the efflorescence, mold and spallings group for the walls and ceilings.

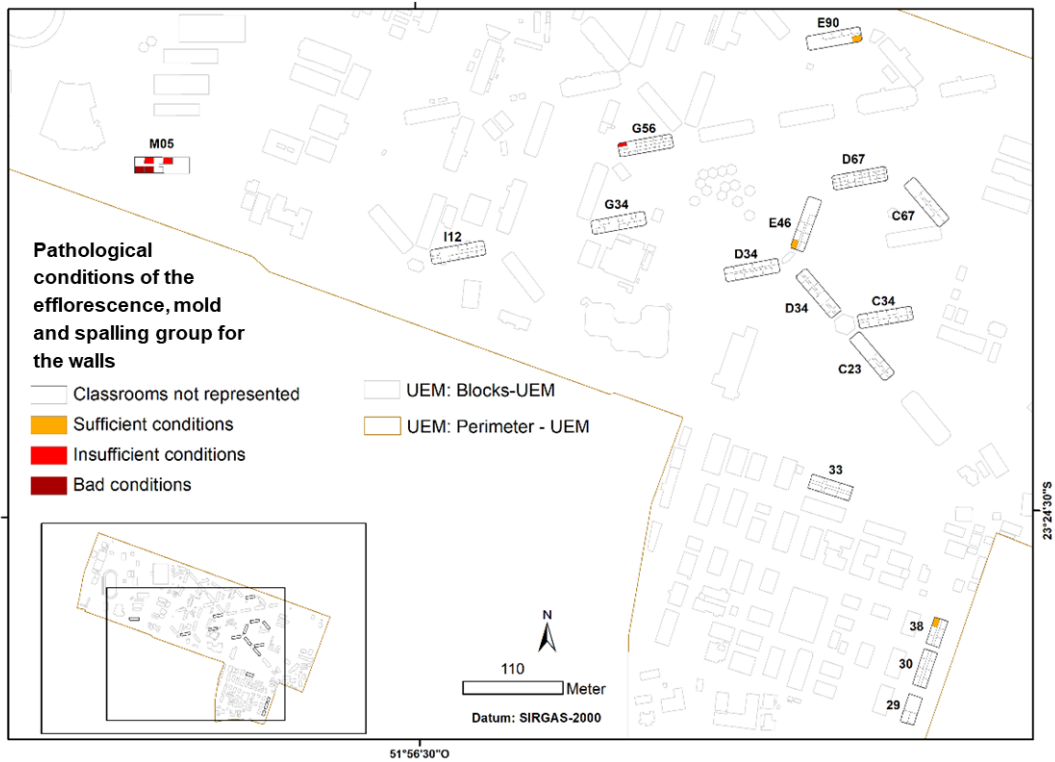
It can be observed in the maps in Figure 6 and Figure 7 that blocks M05 (regarding the walls) and G56 (regarding the ceiling) are in conditions of insufficiency or bad conditions in relation to the other blocks, *i.e.*, they present two or more punctual or non-punctual manifestations. Of the seven rooms in M05, four of them were in conditions of insufficiency or bad conditions (more than 50% of the rooms), two in conditions of insufficiency and two were in the bad conditions.

Figure 6. Pathological conditions of the efflorescence, mold and spalling group of the classrooms for the walls.

In block G56, of the nineteen rooms, eight were in a situation of sufficiency, insufficiency or worse conditions (just over 40%), with one room being in sufficient conditions, four were in insufficient conditions and three were in the bad conditions. Thus, it is understood that such rooms need urgent attention on the part of managers. Again, it is observed that there is a prevalence of equal conditions in the rooms in the same block.

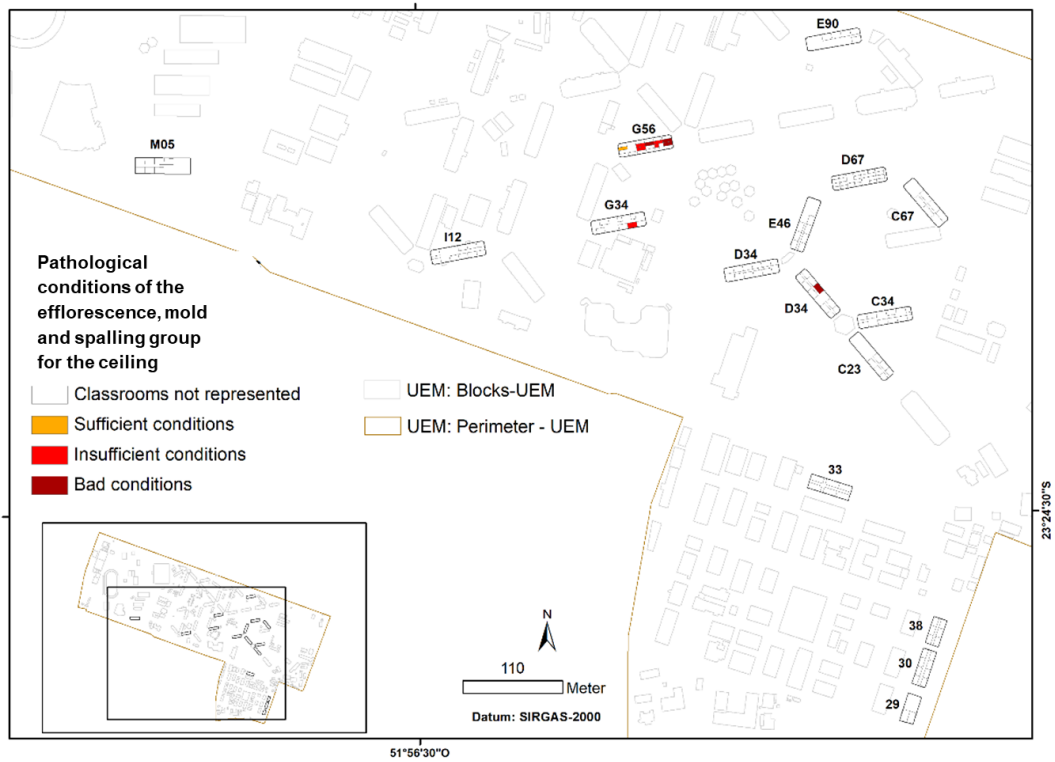
Figure 7. Pathological conditions of the efflorescence, mold and spalling group of the classrooms for the ceilings.

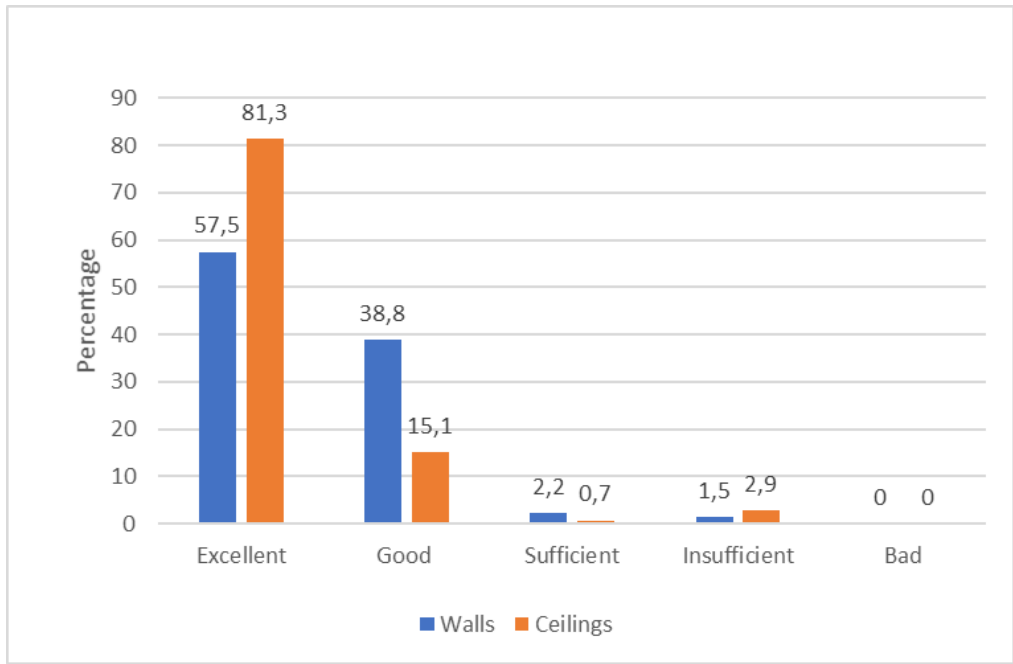
In relation to the investigation regarding fissures, medium cracks and large cracks on the walls and ceilings, it can be observed from the results presented in the Graph of Figure 8 that the majority (more than 80%) of the rooms were in excellent or good conditions.

Figure 8. Percentage of the pathological conditions of the classrooms regarding to the fissures, medium cracks and large cracks group for the walls and ceilings.

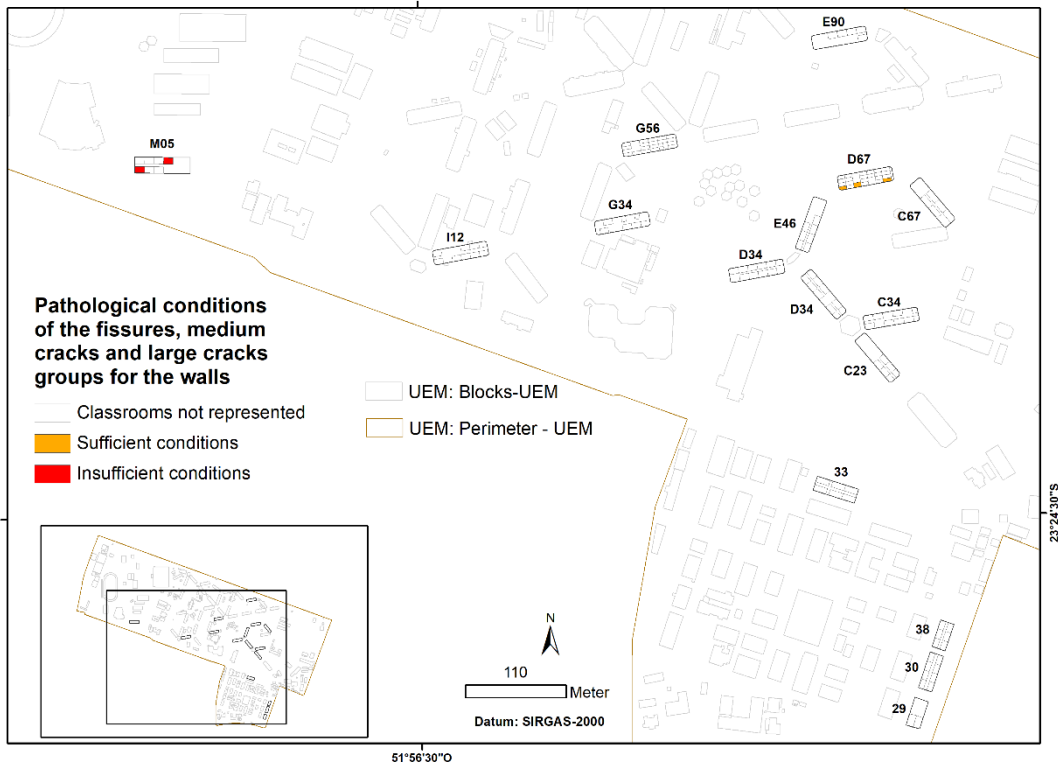
From the Maps in Figures 9 and 10, it can be observed that the events that led to the sufficiency and insufficiency classifications occur concentrated in Blocks M05 and D67, with two rooms in conditions of insufficiency and three rooms in conditions of sufficiency in the walls, and in blocks G34 (3 rooms) and C23 (2 rooms), respectively, in the ceilings. As well as the pathologies regarding efflorescence, mold, stains and spalling, the pathologies of fissures, medium cracks and large cracks must be inspected and analyzed technically.

Figure 9. Pathological conditions of Fissures, Medium Cracks or Large Cracks group of the classrooms for the walls.

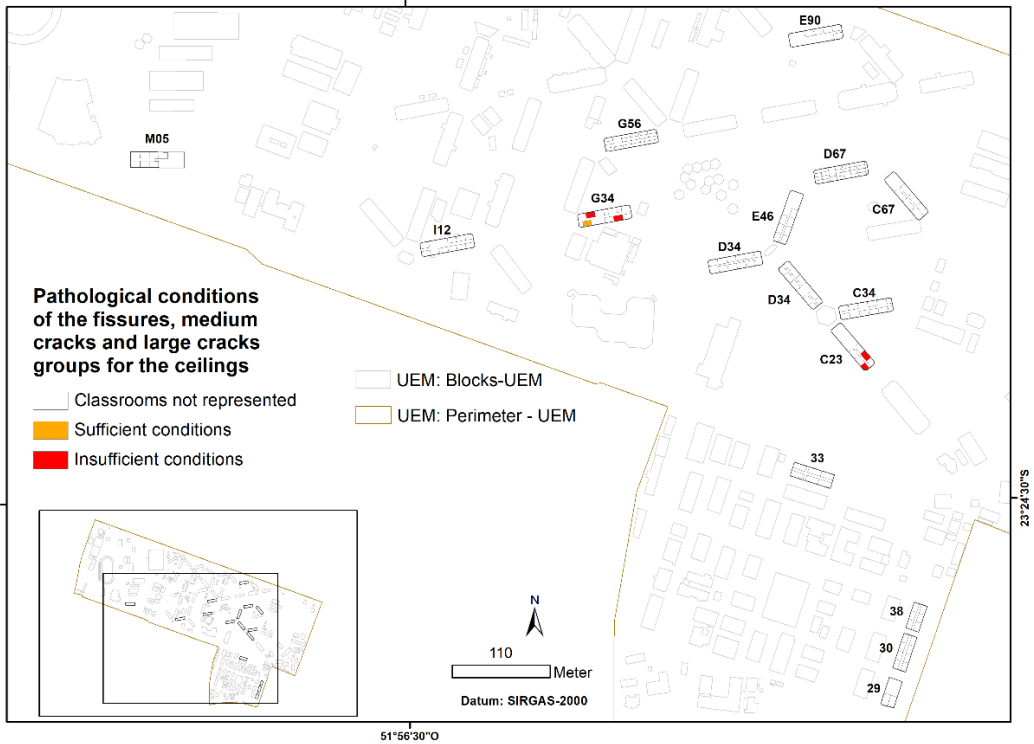
Figure 10. Pathological conditions of Fissures, Medium Cracks or Large Cracks group of the classrooms for the ceilings

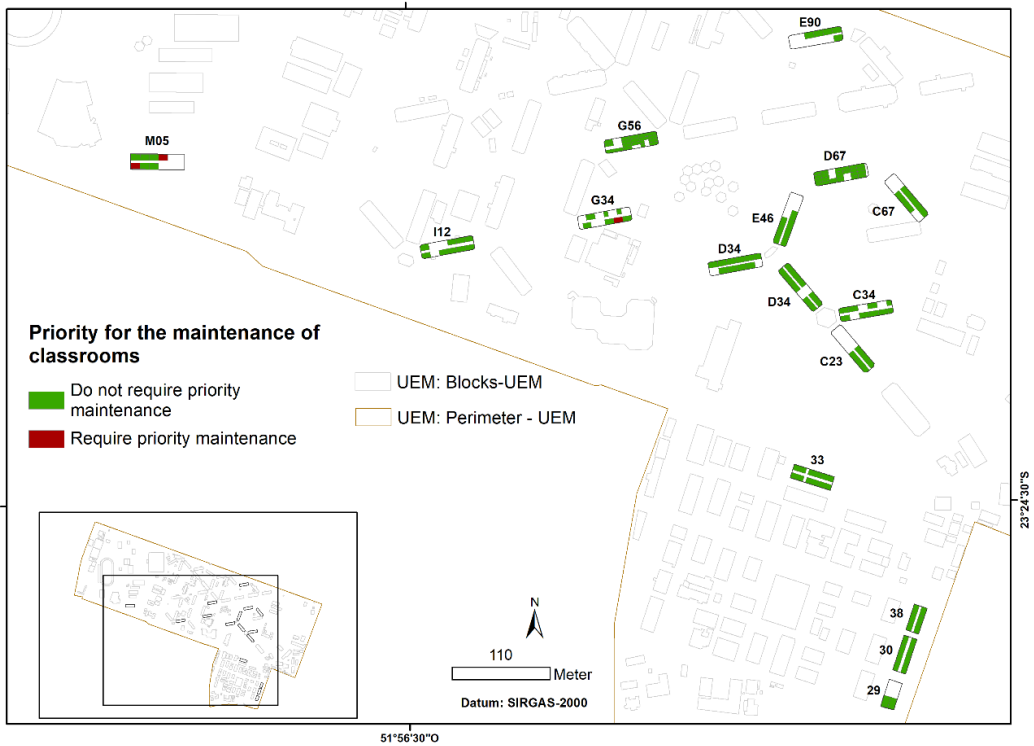
Finally, the map in Figure 11 presents a synthesis of the rooms that obtained the lowest index in the average of the conservation groups (less than or equal to 3) and the highest indexes (greater than 4) in order to analyze which rooms need maintenance priority and which do not need.

Figure 11. Classrooms that require priority maintenance by UEM managers.

It can be observed that the university has mostly (more than 95%) of the didactic rooms in good or excellent conservation conditions. However, it is worth mentioning that the rooms in the M05 block and a room in the G34 block, obtained indexes lower than or equal to 3, for the average of the items investigated. In this way, it is understood that such rooms are a priority for the realization of maintenance and should be inspected by the managers.
