PATHOLOGICAL MANIFESTATIONS IN BUILDINGS WITH REINFORCED CONCRETE WALLS: CASE STUDY IN THE CITY OF JOÃO PESSOA - PB

Abstract: This work focuses on the evaluation of the pathological manifestations presented in the constructive system of cast-in-place concrete walls with the use of steel formwork. The case study was carried out in a condominium, located in the city of João Pessoa/PB, composed of 208 housing units distributed in 13 blocks, each of them containing 16 apartments. The objective of this article is to point out the pathological manifestations reported by the users of the buildings after the completion of the construction and the possible failures in the execution stage. The development of this study consists basically of a mapping of the pathologies through the occurrence reports registered by the users who requested technical assistance, where it could be verified that, of the of all occurrences recorded by the company, around 40% of them are related to, or are from systems that interface with concrete walls. In the next step, an on-site inspection to identify the nature and origin of the pathologies and diagnose the situation found seeking a solution to the problem. It

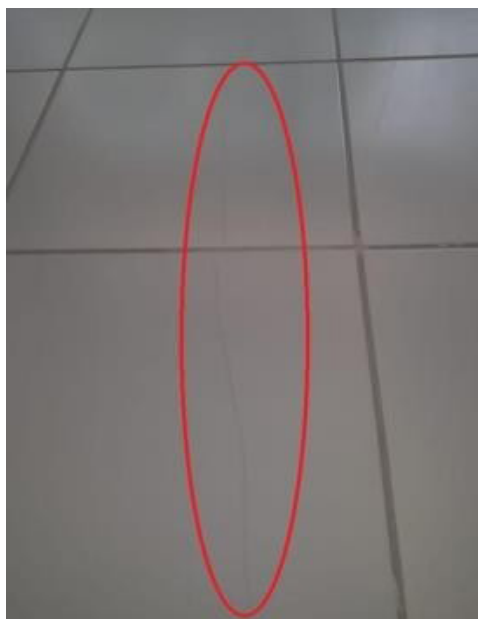
Among the 37.21% of complaints of cracks in ceramics, 16.43% of them were from the failure of the covering of the conduits, that is, when there is interference, such as iron fittings, conduits, or any element inside the concrete mass inside the concrete mass, if the cover is insufficient, after the concrete, when supported on these interferences, it bends, causing cracks. Poor positioning of the spacers or excessive vibration on site, move the conduits and, consequently, reduce their cover.

Another factor observed was shrinkage by drying, because, by properly curing of the concrete, which should be thoroughly watered in the first days of life, the sun exposure or excessive heat of the environment can be prevented from causing the drying out of the newly poured concrete. These situations cited caused cracks in the slab, reaching the subfloor and even the detachment of them in the ceramic tiles, as observed in Figure 7.

Figure 7. Crack in the floor due to failure in the covering of the conduit (Construction Company Archive, 2020).

The correction of this pathological manifestation, as shown in Figure 8, was made through the removal of the cracked ceramic tiles, the laying mortar and removal of the regularizing layer of the subfloor. Next, the micro-crack was reopening and cleaning of the micro-cracks in the concrete slab, application of polyurethane sealant structured with polyester mesh on the entire extent of the crack. Finally, the subfloor was resurfaced; a layer of polyester mesh was applied with ACII mortar and new ceramic tiles were resealed.

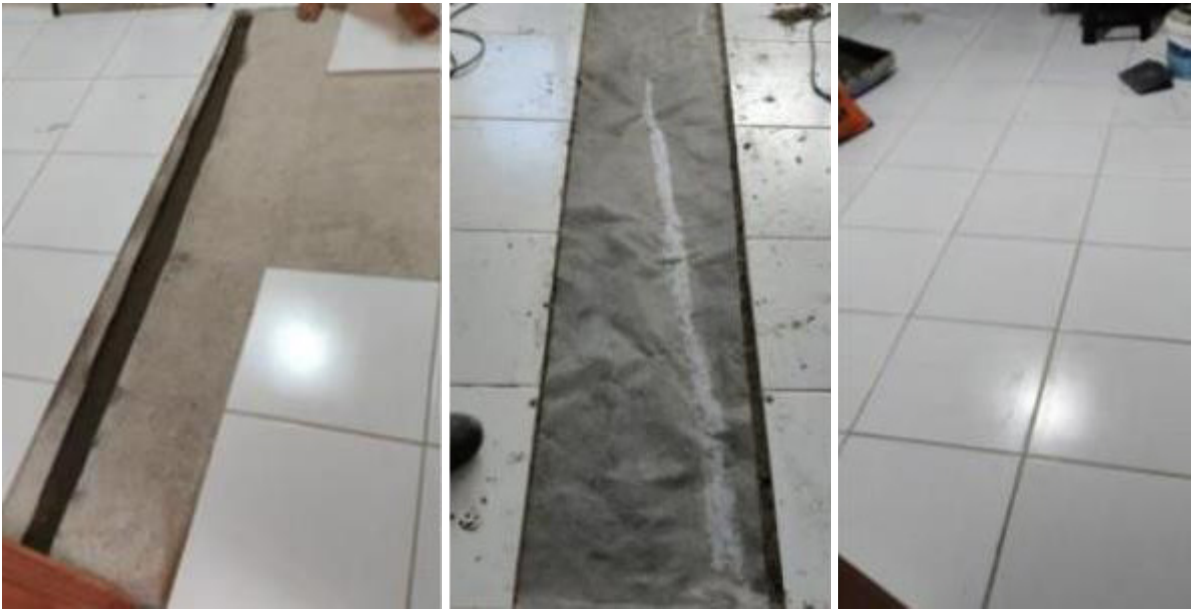
Figure 8. Correction of a crack in the floor due to a failure of the failure of the conduit cover (Construction Company Archive, 2020).

Observing the photos in Figure 8, the first image shows the application of polyurethane sealant, known as “PU”. This material has the function of sealing joints and openings between substrates, preventing water, air or other substances from entering or leaving the structure. In addition to the sealants’ ability to move with the substrate where it has been applied. The central image shows the application of the polyester fabric or polyester veil with the purpose of distributing the tensions in the tensions in regions of greater movement. And the photo on the right shows the resettlement of the new ceramics and, therefore, the finished service.

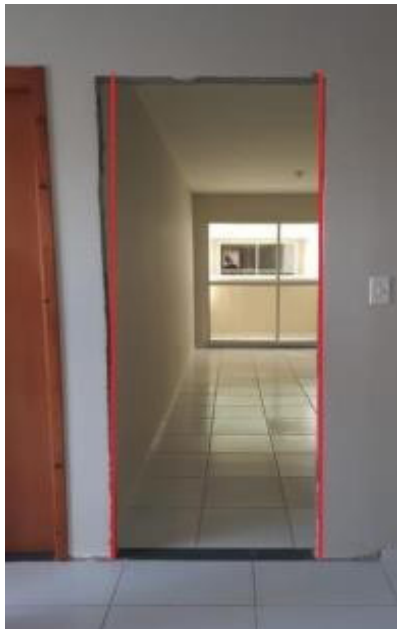
The locking and alignment after inserting the door and window frames and window frames, as well as regularizing their geometry, are fundamental to ensure that the spans are not out of square, as illustrated in Figure 9. For, this flaw directly interferes with the installation and functionality of the frames. Of the 45.25% of requests for assistance, 10% came from doors leaning against the ceiling or the floor, making it difficult to close them, making it difficult to close them. As a result, for regularization, there was an excessive consumption of material due to the great thickness required of the mortar layer for settlement.

Figure 9. Doorway out of square (Construction Company Archive, 2020).

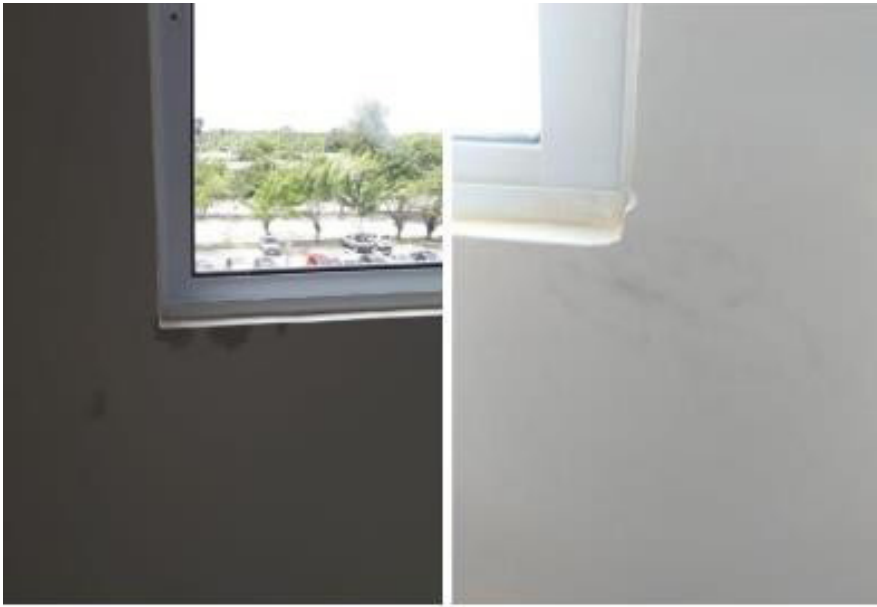
In some cases, infiltration occurs through the appearance of cracks forming angle of 45° with the horizontal, caused, normally, by lack or bad positioning of the reinforcement around these spans linked to a faulty sealing in the placement of the faulty sealing in the

placement of the frame. This example can be seen in Figure 10.

Figure 10. Infiltration at window frames (Construction Company Archive, 2020).

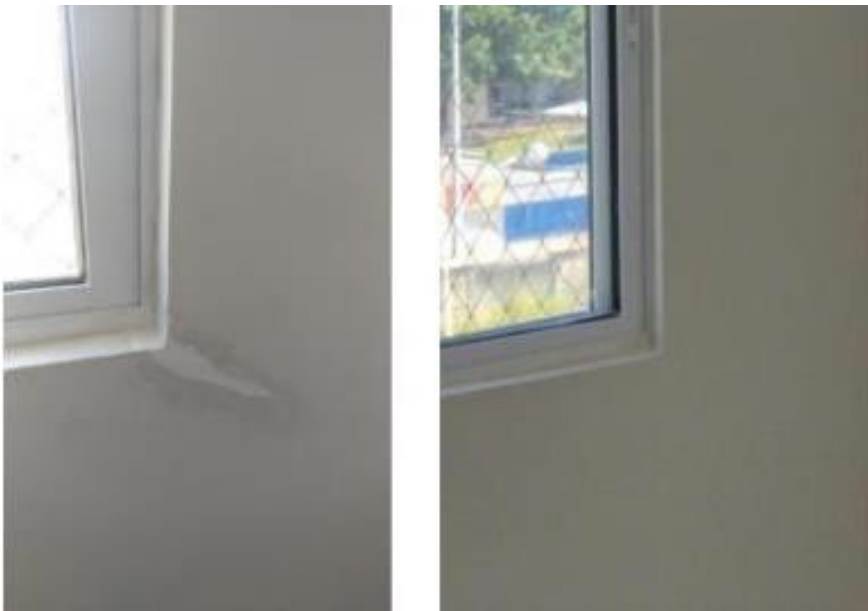
Figure 11. Correcting infiltration in window frames (Construction Company Archive, 2020).

For correction (Figure 11), the micro-cracks were reopened in the layers of paint and mass until it reached the concrete; then the reopening of the micro-crack in the concrete, cleaning of the micro-crack and application of acrylic resin-based crack sealer. Finally, the finishing is done with plastering and painting.

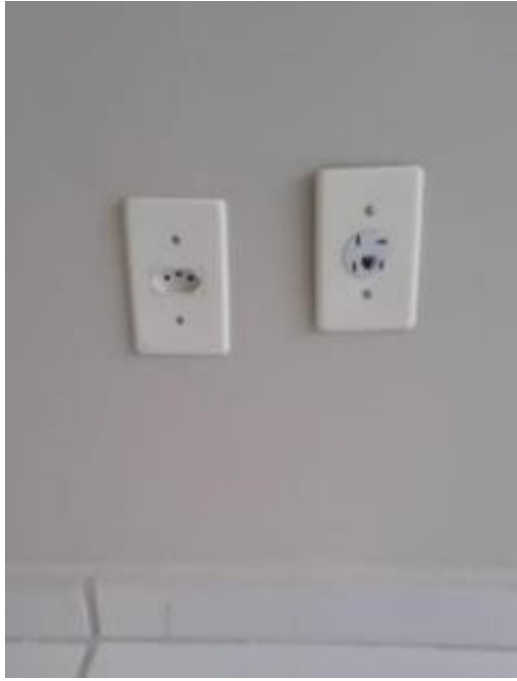
A common scenario after stripping was the misaligned and out-of-round electrical boxes misaligned and out of square, because of the clamp attached to the box, which the steel mesh, could not resist the efforts of the concrete efficiently, as shown in Figure 12.

Figure 12. Misaligned electrical boxes (Construction Company Archive, 2020).

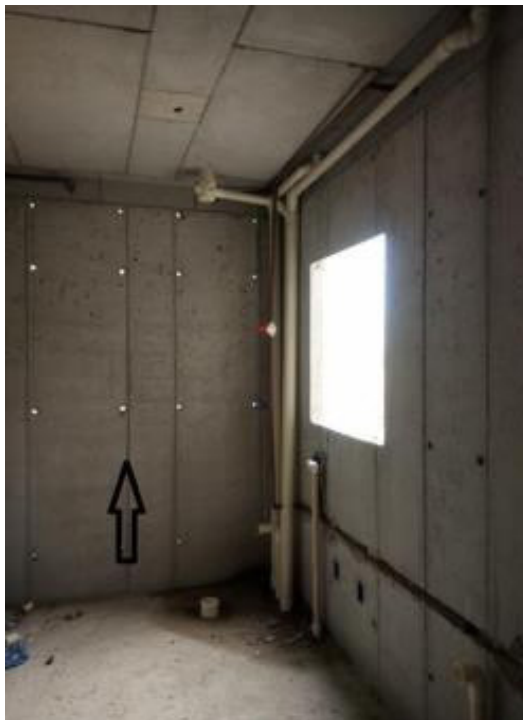
Among the occurrences in the wall structure, we can mention the region of the formwork joints of the forms, where the failure in the concreting in this region, identified independently segregation due to the accumulation of concrete, which caused the exit of due to poor formwork sealing, in addition to a wall with a rough and porous surface. Figure 13 is an example of the cases observed.

Figure 13. Wall with porous and rough surface (Construction Company Archive, 2020).

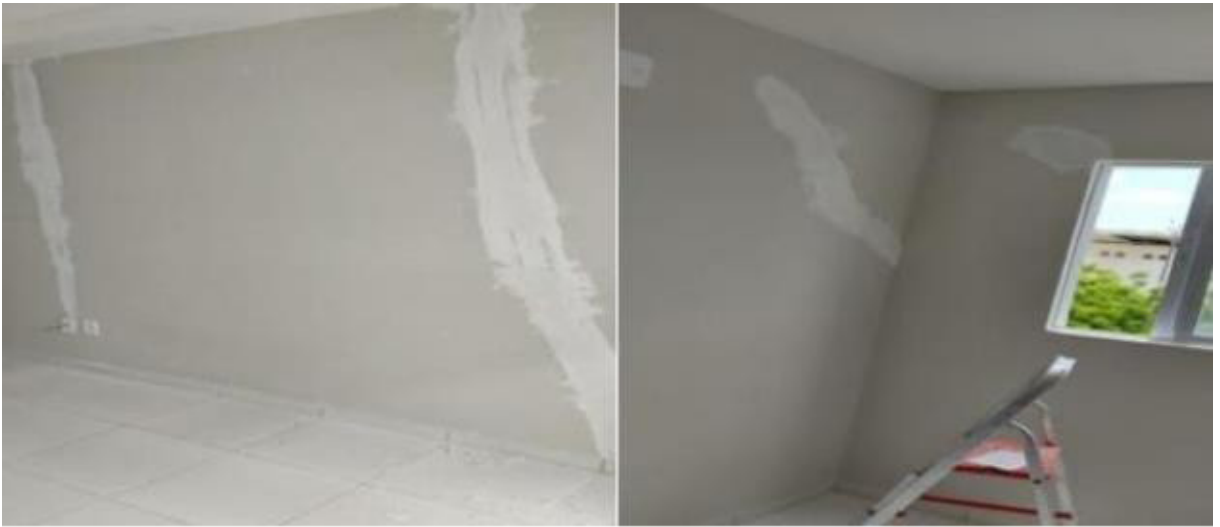
Another reported crack was in the wall of the bedroom where the air-conditioning drainage pipe runs. And, in the room from the opening of an electrical box, which are caused by the lack or poor positioning of the reinforcement. For correction, the micro-cracks were reopened in the layers of paint and mass until it reached the concrete; then the reopening of the micro-crack in the concrete, cleaning of the crack and application of acrylic resin-based crack sealer. Finally, plastering and painting in the crack location. As shown in Figure 14. A image on the left shows the correction made in the room starting from the opening of an electrical box. The image on the right side shows the bedroom wall, where the air-conditioner's drainage pipe.

Figure 14. Wall crack repair (Construction Company Archive, 2020).

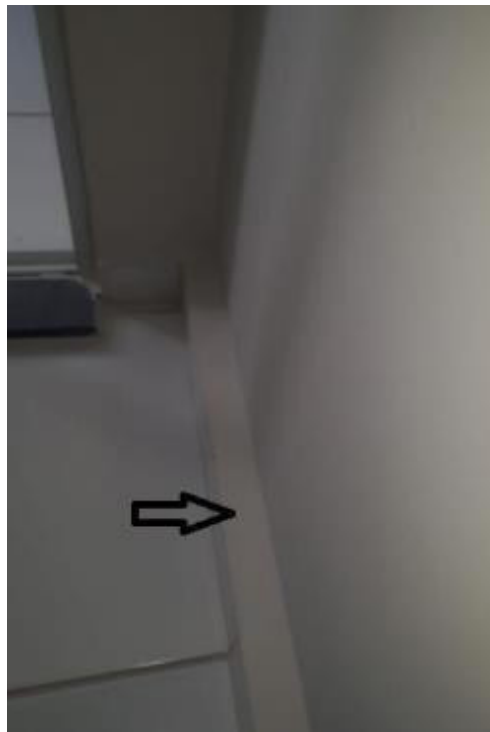
Another request for technical assistance that was frequently reported by the residents after the delivery was that the walls were out of square. According to the manufacturer, the formwork, after assembled, would not move. However, it was found that several walls were out of plumb and square, due to their displacement. This example can be seen in Figure 15, where the floor is squared due to the paging done in the project. To treat the walls with this constructive flaw, an analysis was performed to define which procedure would be best: filling or scarifying these walls.

Figure 15. Out of square wall (Construction Company Archive, 2020).
