## DAMAGE EVALUATION OF ASTM A572 HSLA STEEL AFTER A REAL FIRE EXPOSITION IN SERVICE CONDITIONS

**Abstract:** This metallurgical research determined the mechanical properties of steel ASTM A572 grade 60 that was subjected to fire incident. Mechanical properties were obtained by axial tension test and Rockwell hardness giving similar results than the typical ones observed in original material. A microstructural analysis was carried out obtaining micrographs using optical microscopy. The damaged steel was also analyzed by scanning electron microscopy to analyze the microstructure features after the fire exposition. These images were used to determine a percentage of phases employing the Image J free software. The results didn't reveal damage at the bridge by fire because there is not microstructural damage due to the perlitic degradation or martensitic transformation as well as mechanical properties were not affected neither.

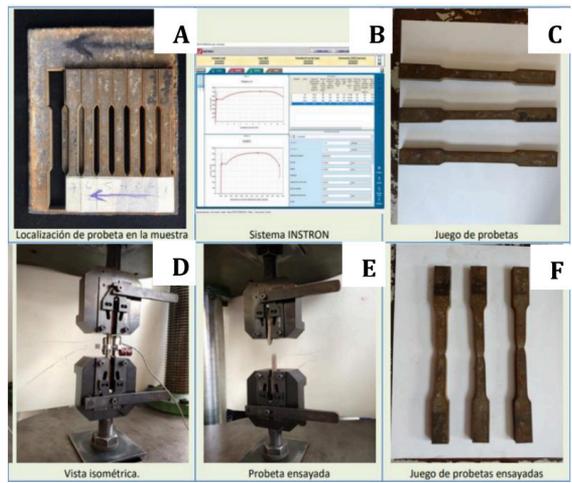
The tensile test is carried out in order to know the toughness, maximum stress, modulus of elasticity and ductility. A universal machine for mechanical tests brand Satec sistem inc was carried out, the specimens for the development of this test were machined with the water jet technique using the plate extracted from the bridge as material, taking the central specimens 3, 4 and 5 to avoid external specimens that could show damaged by cutting process, see Figure 1.

Figure 1. a) Plate obtained from the fired bridge and sectioned into specimens for tension testing, b) Instron software to obtain the results of the stress test, c) Specimens selected for the test, d) Assembly of the Satec sistem inc. universal machine, e) End of the tensile and fracture test of the specimen and f) Set of tested specimens, the fracture is observed in the thinnest area of the specimen.

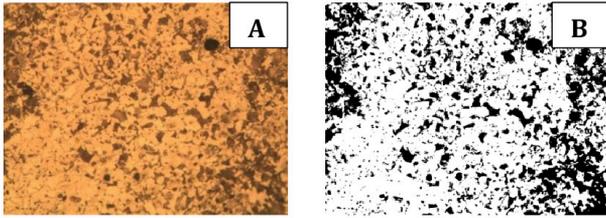
Firstly, the microstructure was obtained using an Olympus Model PMG3 inverted optical microscope. Figure 2a) shows Steel A572 at 200 X, this was attacked with Nital for 4 s, having ferrite and perlite phases, figure 2b) shows the same microstructure modified with free software Image J (Rasband, 2015), the black color corresponds to pearlite phase, and white color is ferrite phase, this allows to

Figure 2. A572 steel at 200X: a) Attacked with Nital for 4 s, the ferrite and pearlite phases are observed in smaller amounts, and grain boundaries are more visible, and b) Modified with Image J software indicating shades of black (pearlite phase) and white (ferrite phase).

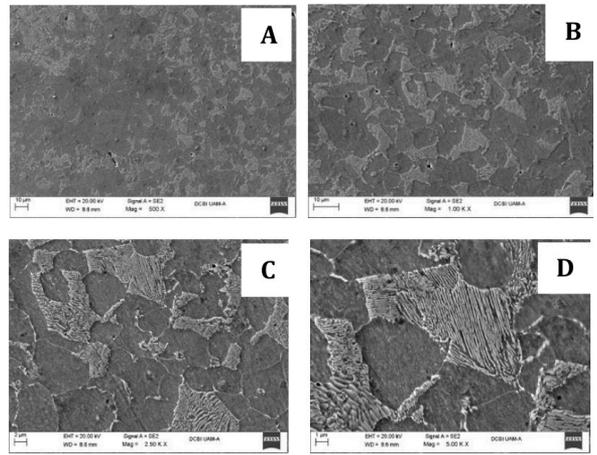
The equipment used to obtain SEM images was a field emission microscope, Carl Zeiss brand, model SURPA 55pV. Figure 3a) shows the present phases of A572 steel, two phases can be seen, as observed at optical microscope, ferrite and pearlite, this last phase is presented in smaller proportion. Figure 3b) shows in better detail and at a higher magnification the phases grain boundaries. The figures 3c) and 3d) images shows a close-up of the pearlite colonies, which allows us to appreciate the characteristic lamellae of the pearlitic phase.

Figure 3. Micrographs obtained by SEM of A572 steel. a) Microstructure with two phases, ferrite which is the dark phase and lamellae of the pearlite phase in a light color, at 500 X both phases are observed, b) 1 KX the limits of both phases are appreciated in detail, c) 2.5 KX approach to the pearlitic phase, and d) 5 KX the characteristic lamellae of the pearlite phase are exhibited.

From the microstructure evaluation obtained by SEM, the ferrite and pearlite (24 %) phases were observed, while there was not presence of hard martensite, therefore there was not microstructural damage as a consequence of the perlitic degradation or instantaneous martensitic transformation.

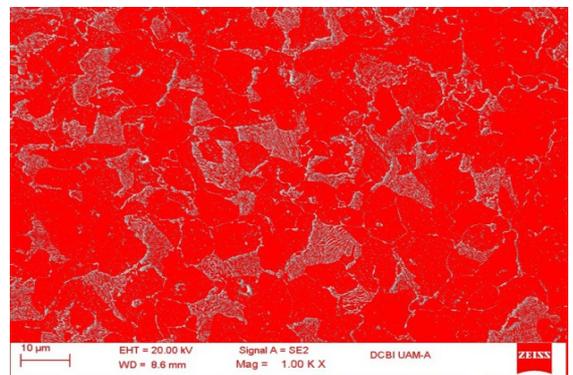
Moreover, the Figure 3b) was used to observe and quantify the phases with the Image J software mentioned above, resulting in Figure 4. In this particular case, the microstructure taken from SEM was at 1 KX, this magnification shows the separation of the phases and allows the accounting for the percentage present of the phases. Table 1 indicates the percentage of ferrite (Zone A) and pearlite (Zone B) phases.

Figure 4. Image showing microstructure processing with Image J software, from Figure 3b) at 1 KX.

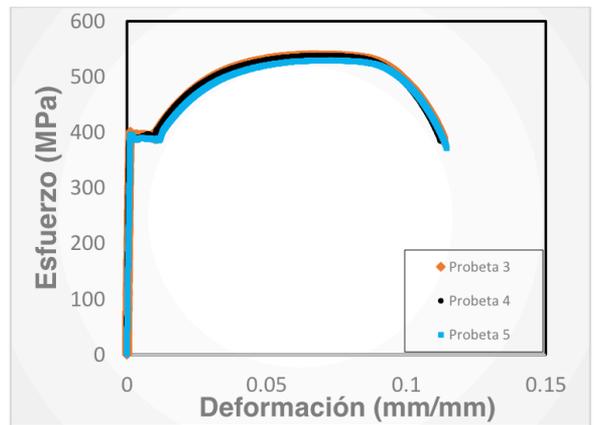
The results of the tensile test were plotted in stress vs. strain curves of the specimens obtained from the incident plate, which are shown in Figure 5.

Figure 5. Stress vs. strain graph of specimens 3, 4 and 5 in Figure 1c) obtained from the incident plate.

When comparing the mechanical properties obtained in this investigation with those described in the standard (ASTM 572/A572M, 2004), it was observed that the yield stress, ultimate stress as well as the percentage of elongation were not reduced in comparison with the values of the aforementioned standard, resulting that the mechanical strength under tension and ductility were not affected by the fire incident in service. Considering the hardness assessment which showed minimal differences, it was guaranteed that the sampling was done correctly by taking different zones of the plate.
