## CASE STUDY: ANALYSIS OF PATHOLOGICAL MANIFESTATIONS FOUND IN THE GARAGE AREA OF A BUILDING IN ARMED CONCRETE LOCATED IN THE CITY OF RECIFE-PE

*Felipe Vasconcelos*

IPOG – Graduate and Graduate Institute  
Goiânia, GO, Brazil  
0000-0003-0869-7570

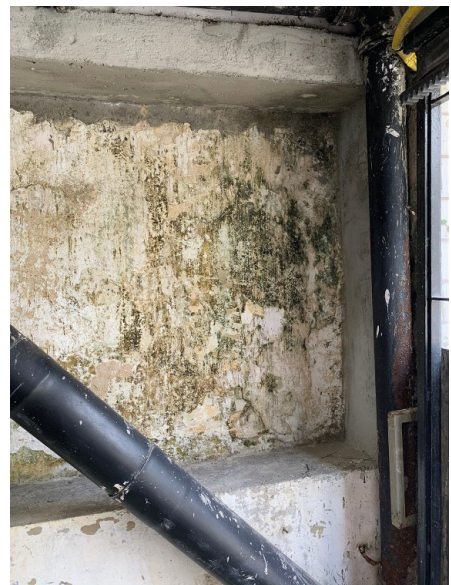
- Visual description: The figure shows the wall next to the exit gate and entrance of cars on the garage floor full of stains, some of which already have a very greenish tone.

- Manifestation: Some areas, when very close to hydraulic elements or even due to lack of sunlight, may end up suffering from the presence of fungi that end up aesthetically damaging that place.

- Probable causes: It can be seen from the figure that the main causes for this pathological manifestation are the presence of a lot of humidity in the environment and also the absence of sunlight in this area, since the masonry is further back in relation to the pillars

and beams. There may also have been a waterproofing problem in the area, probably due to lack of maintenance on the part of the users of the building or failure by the company responsible.

- Mechanism of occurrence: Due to the lack of sunlight, high humidity and lack of proper maintenance at the site, there was a large proliferation of fungi that tends to increase over time if proper corrective maintenance is not carried out.

Figure 6 - Formation of mold on the wall of the garage floor

- Solutions: To treat this type of pathology, you must first treat the cause of this manifestation. Therefore, you must scrape and clean the entire area affected by the mold, and then proceed with a correct waterproofing of that place to reduce the effects of humidity. After that, the area must be repainted with paint with fungicidal action to prevent the appearance of new fungi.

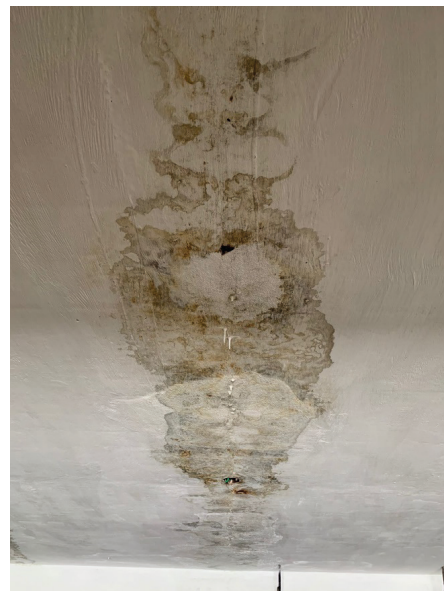
- Visual description: The figure shows the roof of the garage floor with greenish spots and the appearance of white stalactites in the darkest part of these spots.

- Manifestation: The appearance of stalactites demonstrates the presence of the leaching process that occurs in this slab, where water penetrates into the pores and is transported along with the salts to the external surface of the concrete.

- Probable causes: It can be seen from the figure that the main cause for this pathological manifestation is some infiltration that is occurring in the slab that separates the pilotis floor and the garage floor. It can be seen that this infiltration has been occurring for some time due to the coloration of the ceiling, which is already quite green and also due to the formation of the various stalactites scattered by the infiltration stains.

- Mechanism of occurrence: As there are infiltrations in this slab, the leaching process ended up occurring in this concrete. As time went by, the water infiltrated more and more, dragging the calcium hydroxide present in the concrete with it, thus resulting in stains and stalactites on the slab.

Figure 7 - Infiltrations in the ceiling of the garage floor with stalactite formations

- Solutions: In order to treat this type of pathology, first, a study of the level of severity that this pathology caused in the structure must be carried out. After this analysis, if it is something simple, you must clean the entire part affected by the infiltrations and scrape the entire part contaminated by calcium carbonate. However, if the situation is more serious,

structural reinforcement must be carried out on this slab to avoid corrosion of the reinforcement and possible collapse in the future.

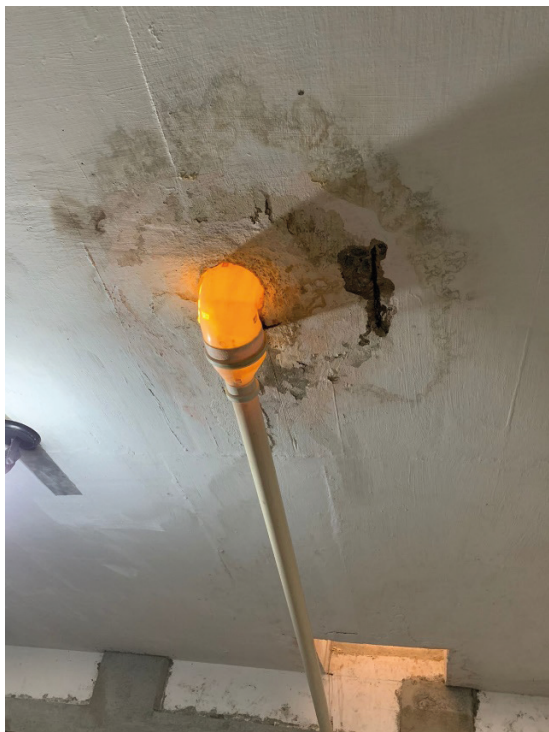
- Visual description: The figure shows the roof of the garage floor and a sewer pipe, where a 90° elbow and approximately 100 mm in diameter is serving as a drain to capture water from the upper floor (pilotis).

- Manifestation: Hydraulic pipes connected to reinforced concrete structures must be very well waterproofed so that there are no leaks that could affect and damage the useful life and durability of the structural elements that are around them.

- Probable causes: It can be seen from the figure that the main cause for this pathological manifestation is the poor waterproofing of the drain in the pilotis,

since the entire part around the pipe is suffering from infiltration.

- Mechanism of occurrence: Due to the absence of proper waterproofing, the water coming from the stilts infiltrates the slab and ends up leaving the garage ceiling full of brownish stains. It is also noticed that due to the infiltrations, the ceiling coating is falling, which is leading to the exposure of the reinforcement and its consequent corrosion.

Figure 8 - Infiltration and exposure of reinforcement on the roof of the garage floor

- Solutions: To treat this type of pathology, you must first properly waterproof the stilt floor drain to prevent further infiltration. Next, the corrosion of the exposed reinforcement must be treated by scraping the rusted part and applying a corrosion inhibitor product to prevent further corrosion. Finally, the infiltrated area is recovered by scraping and carrying out a new application of paint and plaster.
