Scientific Journal of Applied Social and Clinical Science

HISTORICAL ANALYSIS AND GENERAL STATE OF CONSERVATION OF THE MARIETA TEIXEIRA DE CARVALHO MANSION, SÃO PAULO

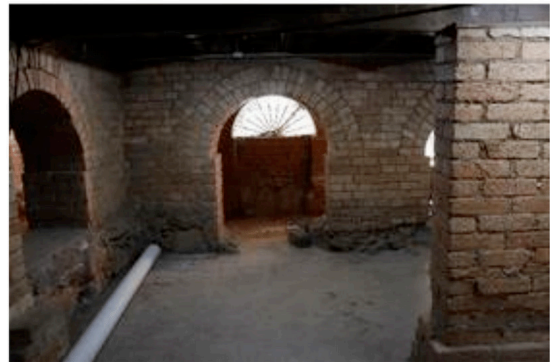
In the basement, which housed the old slave quarters, you can see sections of the mortared stone infrastructure, bricks that emerge from the floor and are overlapped by the walls, also made of baked bricks. As it was the first space to undergo the intervention process, it is in excellent condition, despite the presence of rats and dirt on the concrete tile floor, which is in very good condition (Figure 2).

Figure 2: Underground where we see the use of brick in the infrastructure and base of the walls

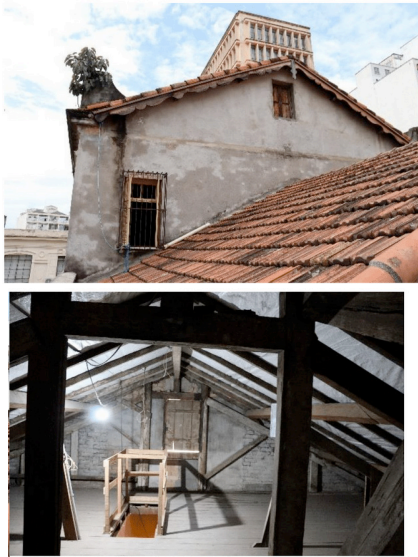
The roof, with a structured wooden structure and French tiles, appears to have also undergone an intervention, as it is covered with a blanket and appears to be in a very good state of conservation, as we can see in Figure 3.

Figure 3: View of the roof in good condition and detail of the blanket placed below it

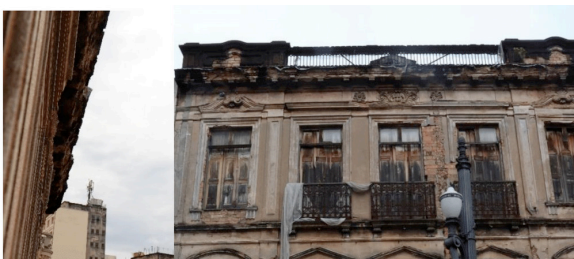
The front facade, which is the main object of study in this work, still retains the beauty and grandeur of its original construction, but shows serious wear caused mainly by lack of maintenance. The plaster is peeling off in several parts and you can see the exposed bricks. It was from this location that the sample was taken to test the mortar used to lay the mortar and perform the plastering (Figure 4).

Figure 4: Facade elements where we notice plaster detachment

In general, the facade is reasonably preserved, and the tests presented in section 4 prove that there are no serious agents causing wear and tear on its elements. Therefore, bad weather and time are the main agents identified, in addition to the lack of maintenance of the property as a whole.

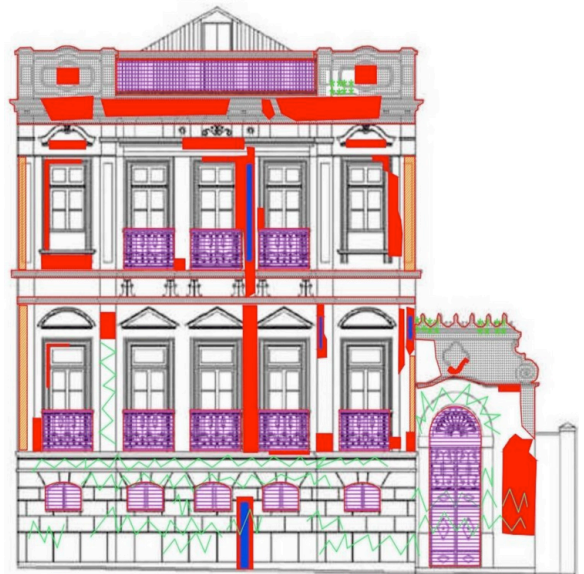
Figure 6: Facade representation of the damage map

To execute the Damage Map, graphic coding was carried out in detail in Table 1, characterizing the pathologies and damage found on the main facade of the Palace, and, further down, in Figure 6, the representation of the position of the damage therein.
