Journal of Engineering Research

USE OF UNMANNED AERIAL VEHICLES (DRONES) FOR THE AUSCULTATION OF HISTORIC ARCHITECTURAL FEATURES AND ANCIENT STRUCTURES

Rubén Rodríguez Elizalde

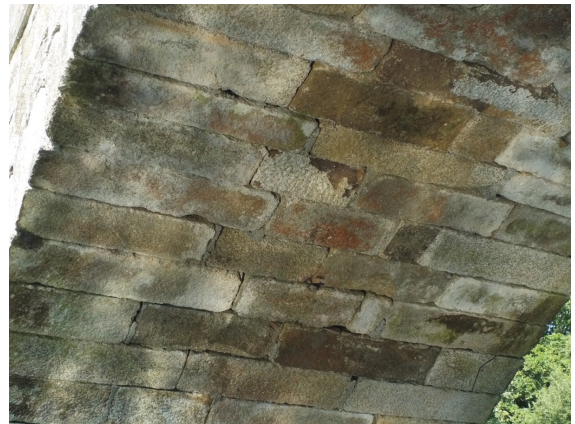
The soffit of the vaults is undoubtedly the most critical point from the pathological point of view and also the most difficult to access for inspection by manual means. As can be seen (Figure 8), all the elements that make up the vaults are made of granite, with ashlars and voussoirs dry-laid, being the rounding of the vertices, characteristic of the alteration of the granite (García de Miguel, 2009), one of the most remarkable aspects.

Figure 8 - General view of the downstream elevation of the Brandomil Bridge, in an image captured with the multi-rotor drone used in the inspection of this article (photo by the author).

The granite constitutive of the monument presents, in the interior of the vaults, certain deteriorations as a consequence of the synergy of actions of diverse nature, fundamentally chemical and biological. Thus, the formation of several black crusts can be observed

(Figure 8), presumably linked to the action of contaminating agents (particularly sulfur compounds). Together with these crusts, there is an abundant presence of biocolonies (plants), which have grown rooting in the joints between the ashlars, especially in the joints of angular points (Figure 9 and Figure 10), which enter in feedback with the phenomena of humidity, efflorescence and runoff water, as reflected by certain observed stains.

Also linked to the humidity is the proliferation of small carbonation crusts, detected in the interior of the vaults: in this case, they are crusts due, fundamentally, to the dissolution of calcium carbonate coming from the mortar placed between the ashlar joints. The dark marks of runoff water, observed in some points of the bridge, are linked to this process of development of black crusts.

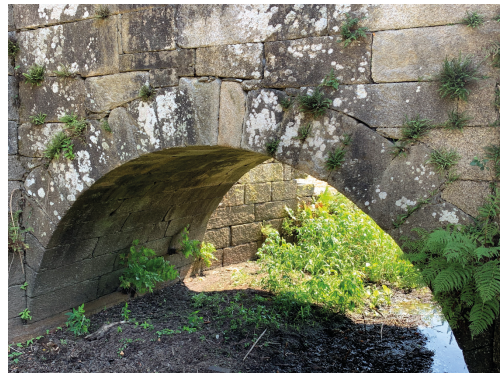
Figure 9 - General view of the smaller arch of the Brandomil Bridge, seen from the upstream side, in an image captured with the multi-rotor drone used in the inspection, where the abundant presence of vegetation rooted in the multiple elements can be observed (photo by the author).

This section closes by reiterating the presence of vegetation rooted in the joints between the ashlar (Figure 9 and Figure 10). Because of the humidity, and given the susceptibility of the granite to biological attack, the drone was also able to record films or mottling, resulting from the accumulation of plant microorganisms, such as moss or similar (Figure 9 and Figure 10).

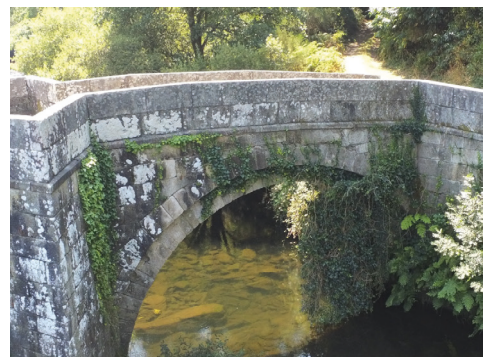
Figure 10 - view of one of the major arches of the Brandomil Bridge, seen from the upstream side, in an image captured with the multi-rotor drone used in the inspection, where the abundant presence of vegetation rooted in the multiple elements can be observed (photo by the author).
