## MANDIBULAR ANGLE FRACTURE DUE TO THIRD MOLAR EXTRACTION: CASE REPORT

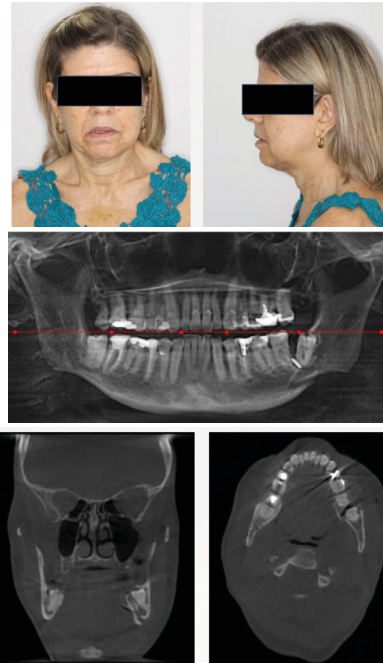
Coronal and axial section of computed tomography
