Journal of Engineering Research

SPLIT CONTAINER FOR LEAKS, WITH RUBBER SEALING RINGS

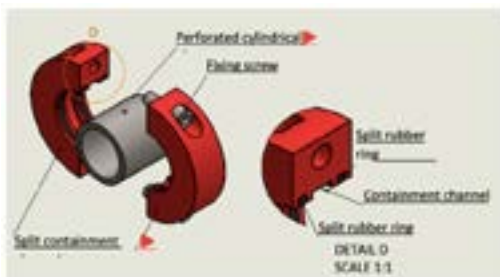
Fig. 1

It is easy to see that the two parts of a split rubber ring will not provide a seal when joined in an assembly where they are pressed against each other, as shown in Fig. 1.

So, how can sealing be achieved in this case? As mentioned above, we cannot simply split a sealing ring and then join them together to promote sealing between them. With the internal part pressurized, the rings would move apart and, consequently, sealing would not occur.

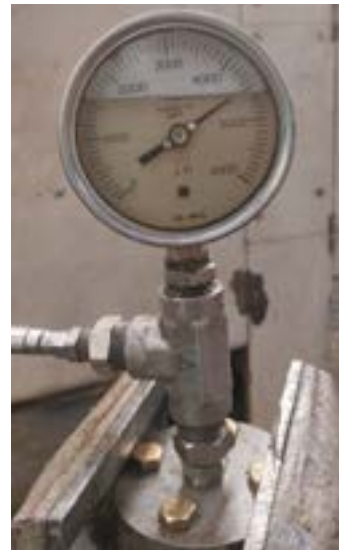
Fig. 4

The hydrostatic test for this project would be 1.3 times the working pressure, but as this particular test would serve as a basis for future new applications, we chose to perform it at 1.5 times the working

pressure of 3,000 psi, or 4,500 psi. The test yielded positive results, confirming the effectiveness of the unprecedented assembly (see Fig. 4).

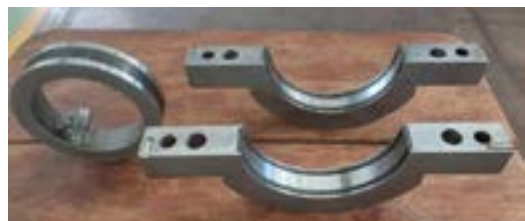
Fig. 5. (Prototype of the split container disassembled)Hydrostatic test of the split container prototype

Finally, the container prototype was designed, manufactured, and tested at 3,900 psi (1.3 times the working pressure), as shown in Figure 5, confirming the effectiveness of the seal.

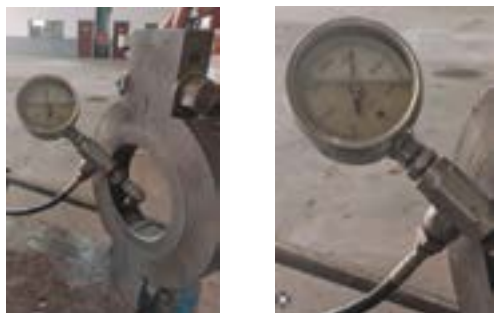
Fig. 6. (Hydrostatic test with 1.3x working pressure = 3,900 psi.)
