## CHEMICAL ANALYSIS OF FINE AGGREGATE FROM RIO DOCE AND ITS INFLUENCE ON THE DURABILITY, STRENGTH AND CARBONATION OF CONCRETE

**Abstract:** This work aims to evaluate the influence of the fine aggregate extracted from the Rio Doce river in the possible appearance of pathologies of the concrete, since the river has a history of contamination by substances from mining waste. The probability of the emergence of pathologies in the concrete can be high depending on the physical and chemical characteristics of the fine aggregate used, such as the corrosion of the concrete and the reinforcement, putting its durability at risk. As the Rio Doce is the largest granulometric source of civil construction in the city of Colatina, a better analysis of the characteristics of the concrete used in local constructions is essential. For the analysis, three rivers were selected, in addition to Rio Doce, being them the Pancas, the Santa Maria and the Santa Joana rivers, in order to raise comparative and qualitative parameters between them. The concrete samples were submitted to axial compression strength tests, carbonation test and corrosion potential test through electrochemical method, being possib

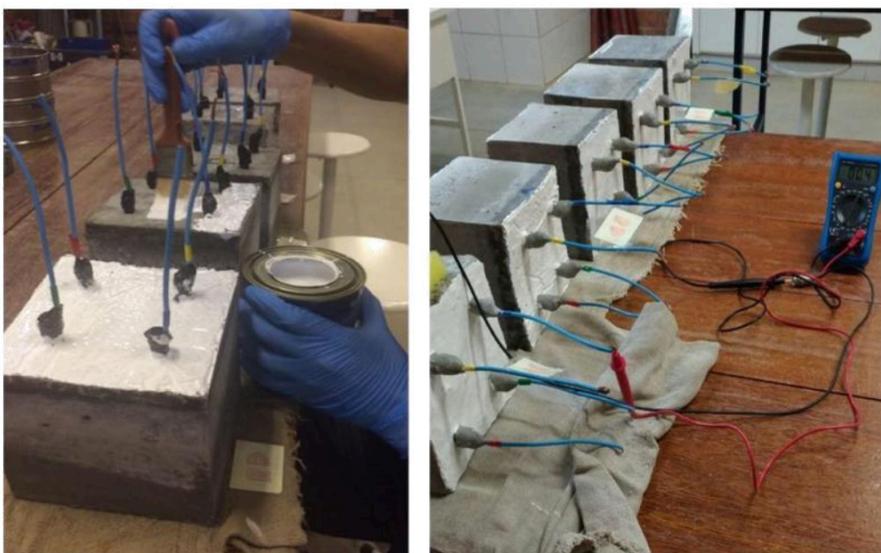
At the upper end of the bars, in the exposed part, flexible wires were connected to provide the electrical connection during the test. Insulating tape was used to protect the connection between the flexible wires and the bars, and epoxy resin was applied over the tape. The upper and lower faces of the specimens were also waterproofed with epoxy resin, preventing the entry of aggressive agents and inducing the corrosive process on the side of the specimen (DOTTO, 2006; SILVA, 2010). Stickers were placed on the bars of each specimen to facilitate the measurement, using the colors blue, yellow, green and red (Figure 1).

Figure 1 – Waterproofing with epoxy resin in cubic specimens and measurement of corrosive potential test, respectively. Source: author's collection (2017).

After curing, the cubic specimens were induced to corrosion through wetting cycles by partial immersion in a 3.5% NaCl solution for 2 days and drying cycles characterized by storage in an oven at 50°C for 5 days, with the potentials measured after each half-cycle (SILVA, 2010; PEREIRA, 2012). Measurements were performed on all bars on only two sides of the specimen with the aid of distilled water, a sponge, a silver/silver chloride electrode and a multimeter. Soon after, the arithmetic mean of the potential values of each sample was obtained, in order to perform a global analysis by sample and not by bars. Due to a failure with the silver/silver chloride electrode, it was not possible to carry out the measurements in the first cycles, with the measurement started in the eighth cycle and ended 70 days after the beginning of the corrosion induction test.

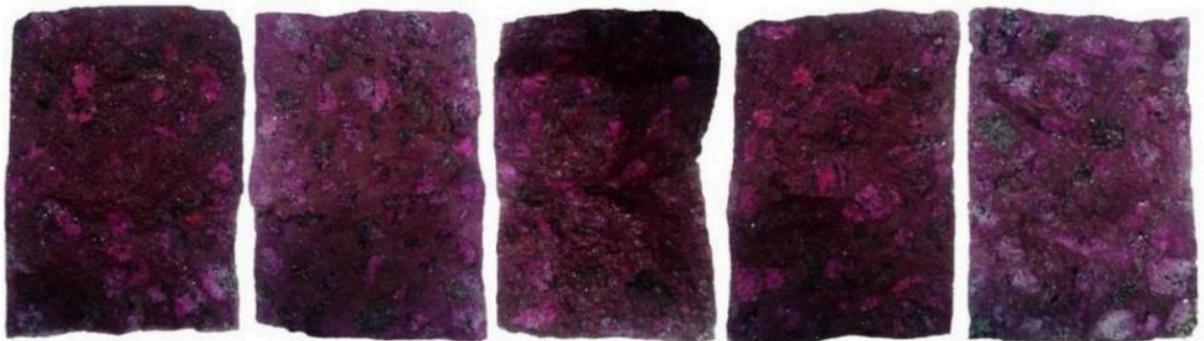
Figure 2 shows the images of the five specimens that were ruptured and submitted to the carbonation test, where five depth measurements were taken with a digital caliper on the surface of each specimen.

Figure 2 - Photograph of the carbonation test of samples from Rio Doce (A1), Rio Doce (A2), Pancas, Santa Maria and Santa Joana, from left to right, respectively. Source: Author's collection (2017).

Through the carbonation depth data, it was possible to calculate the Kc coefficient, which represents the carbonation velocity of the studied concretes. The values of the carbonation depths, together with the respective Kc coefficients and the values of average concrete compressive strength, in MPa, are shown in Table 2.

The samples from the Rio Doce (A1) and Santa Maria show the highest average values of concrete compressive strength (MPa), while the samples from the Pancas and Santa Joana rivers show the lowest values. Samples from the Santa Joana and Pancas rivers showed higher values of carbonation depth, while Rio Doce (A2) and Santa Maria

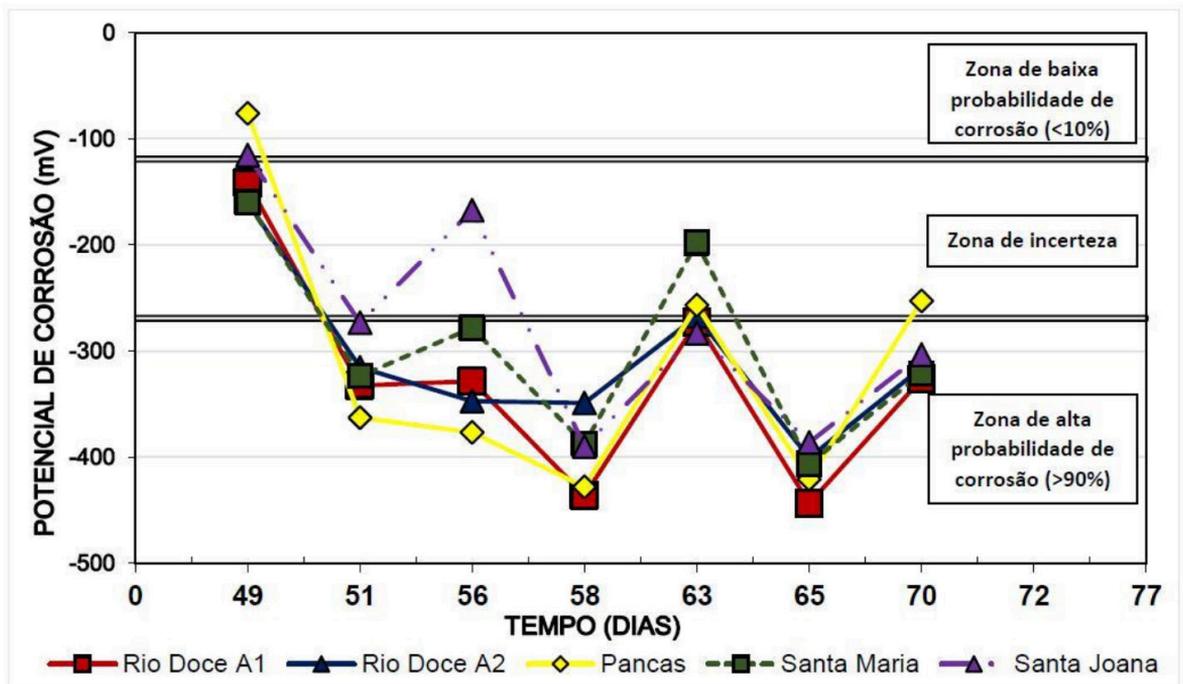
As for the corrosion potential test, it is noted that the Pancas and Rio Doce samples (A1) presented the most negative values located in the zone of high corrosion probability (>90%). The samples from the Santa Maria and Santa Joana rivers exhibited the most positive and most patterned values regarding the discontinuity caused by the wetting and drying cycles (Graph 1).

Graph 1 – Mean values of corrosion potentials according to the number of days after the beginning of the corrosion induction cycles of the different samples. Source: prepared by the author (2017).

Considering the results of corrosion potential, graph 1, the analysis of variance (ANOVA) was performed to verify if there is a statistically significant difference between the samples in relation to the measured values of the corrosion potential. Thus, according to table 5, through analysis of variance per sample and considering that the data have a characteristic of normal distribution, it appears that at the 95% confidence level

there is no statistically significant difference between the sediment samples against the measured values of corrosion potential of steel bars.
