PATHOLOGIES IN PROPERTY DUE TO ABSENCE OF WATERPROOFING - CASE STUDY: BUILDING IN THE CITY OF MANAUS

The study area comprises a commercial building, built in the 80's, located in the city of Manaus-AM. It has 14 floors for circulation, in which the 1st and 14th floors were selected for the observation and analysis of pathologies, places where the greatest number of anomalies were found.

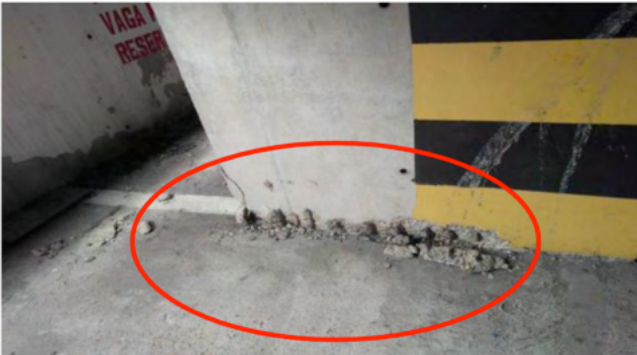
Corrosion of armor - According to Souza and Ripper (1998), reinforcement corrosion is an electrochemical process that requires the simultaneous presence of moisture and oxygen to occur. Due to the insufficient coverage of the reinforcement, which allowed excess moisture to adhere to the part, together with the local temperature variation, corrosion of the steel at the base of the column occurred. (Figure 1).

Figure 1. Corrosion of reinforcement at pillar base
Source: Authors(2018).

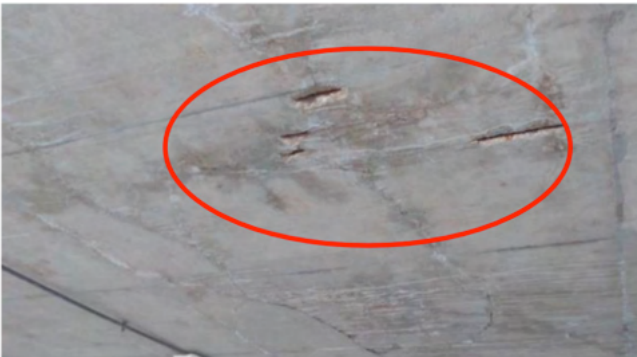
Carbonation in concrete - According to Pedferri and Bertolini (2004), reinforcement corrosion can, however, be induced by the carbonation of the concrete or by the penetration of chlorides. Due to the lack of waterproofing, the structure was exposed to moisture, causing a decrease in the pH of the concrete and depassivation of the reinforcement, with the beginning of corrosion. With this, internal tensions were created and, consequently, the appearance of cracks, causing the displacement of the concrete from the structure. (Figure 2).

Figure 2. Concrete carbonation
Source: Authors(2018).

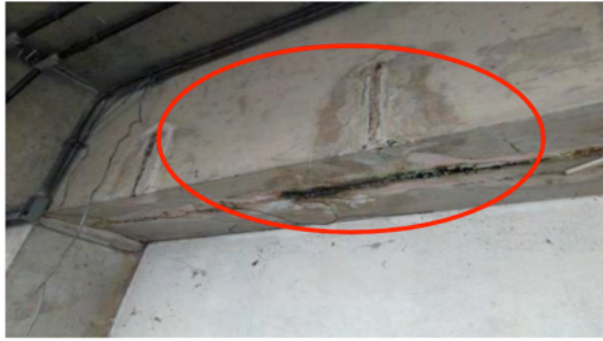
Efflorescence - According to Caporrino (2018), the salts in contact with water dilute and are transported to the external surface, where, in contact with the air, they solidify, causing deposits of white powder, which is a pathology identified by the appearance of whitish stains, in which excess moisture, added to the absence of waterproofing, caused the problem to manifest. (Figure 3).

Figure 3.Efflorescence
Source: Authors(2018).

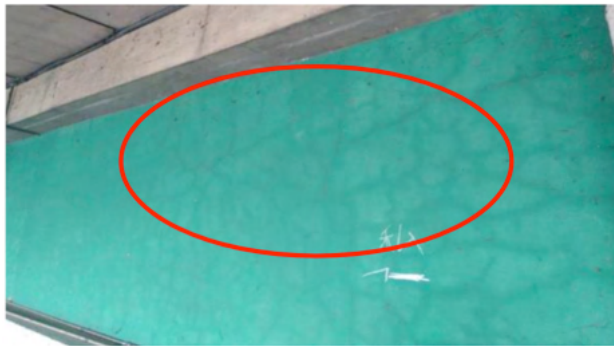
Cracks - According to ABNT NBR 15575-2/2013, cracks are openings greater than 0.6mm in any situation. Therefore, cracks were identified in the plaster caused by the variation of humidity and temperature variation, causing visible damage to the coating: soft mortar and without adherence to the substrate. (Figure 4).

Figure 4. Crack
Source: Authors(2018).

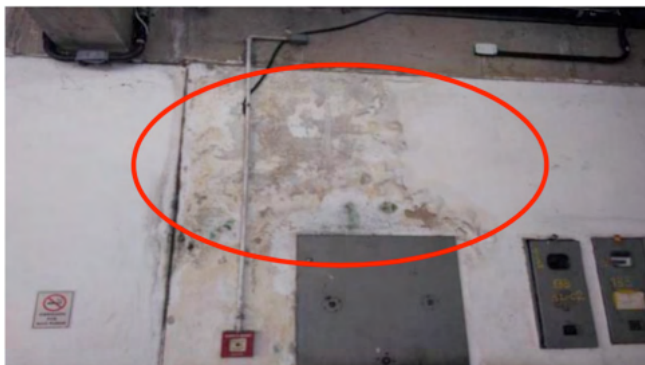
Mold - According to Shirakawa et al., (1995), the term mold is the designation of fungal growth, which occurs by the appearance of dark colored spots of black, brown and green. Due to excessive humidity and poor ventilation, the proliferation of fungi appeared, spreading easily to the environment, causing damage to the paintwork, with unpleasant aspects. This type of problem can result in the emergence of serious illnesses related to the airways. (Figure 5)

Figure 5.Mold
Source: Authors(2018).

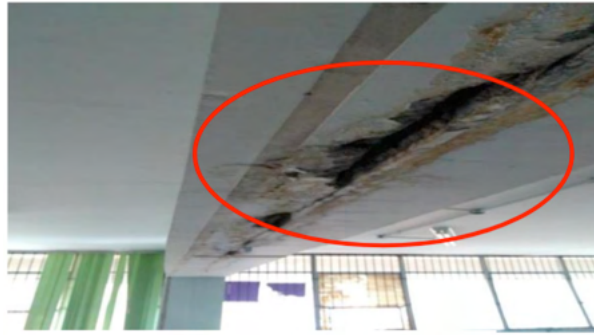
Concrete breakdown - According to Bauer (1987), the breakdown of concrete is characterized by its rupture, especially in salient regions of the structural elements. Considering this concept, the rupture and the surface detachment of the concrete were observed, showing its displacement on the sides of the expansion joint and, in particular, on the projecting parts of the structure. (Figure 6).

Figure 6. Concrete breakdown
