## **CONSERVATION AND RESTORATION OF FIGURATIVE TILES: FROM MANAGING EXPECTATIONS TO INTERVENTION CRITERIA**

*Ânia Chasqueira*

*Ricardo Triães*

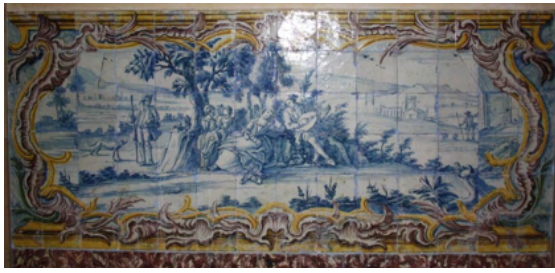
Figure 1 - Example of one of the panels with gallant scenes in the Living Room.

The tile has a considerable presence in the palace, accounting for 64549 tiles. Due to the continuous use over the centuries and the various transformations, this palace preserves an illustrative set of the technological and stylistic evolution of the tile in Portugal (Figure 1 and 2) (RODRIGUES, 2015, pp.51-52). However, the application of some sets in the palace is not always the original, they are reapplications of tiles from other contexts. At the end of the century In the 19th century, the Quinta was acquired by Luís Sommer, undergoing major transformations, namely in the application of patterned tiles from the 19th century. XVII coming from other contexts (RODRIGUES, 2015, p. 26-27) among other types of pieces, some of Italian origin (PEREIRA ET AL., 2020, p.135).

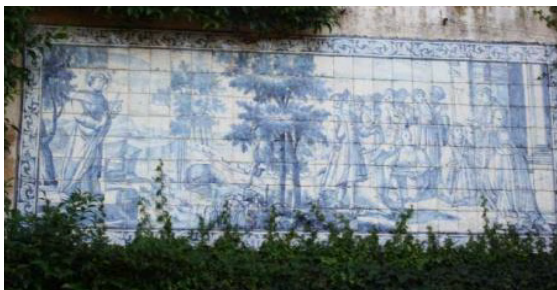
Figure 2 - Tile panel on the main facade.

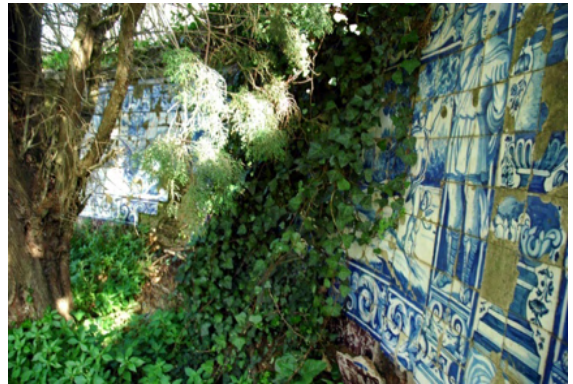
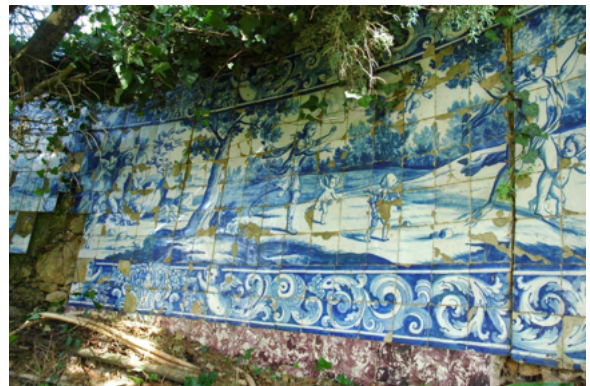
Figure 3 – Panel before the intervention

Figure 4 - Panel before the intervention

The Quinta Nova garden panel was placed in an area currently abandoned, on the edge of the property. Covered by dense vegetation and microorganisms, they contributed to the detachment of the glaze, quite accentuated in some areas. As a result of the loss of the bonding function of the laying mortars, the panel had some tiles missing, which contributed to the weakening of the surrounding tiles and to the loss of reading.

namely the accelerated degradation of the set and its vulnerability in the face of a possible theft attempt, a proposal was presented for the removal of the panel, conservation and future placement in another space, as per owner's wishes.

Due to the very heterogeneous state of conservation between the tiles and the fact that the owner wanted a solution to improve the reading of the whole, it was decided to fill in gaps and cold glaze detachments and their chromatic reintegration.

This intervention criterion motivated the selection of a filling material that would guarantee the same type of application for any student as well as paints in chromatic reintegration. In the areas of missing tiles (in the bar area) it was decided to fill in the gaps with new tiles, slightly differentiating their tonality. This situation was possible given the symmetry in the bar that allowed the redoing of the design. The panel was applied on an acrylic support and fixed in a new location.

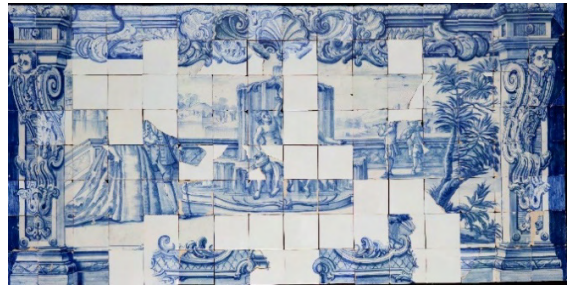
Figure 6 – “Panel 10” of Quinta Nova after the intervention.

In this sense, and in order to improve the possible reading of the panel, it was decided to create new tiles in the frame. Given the symmetry of the frame, it was possible to reproduce a part of the design, and in the remaining areas of gaps, the filling was done with new tiles only with the tone of the glaze (Figure 6). In the case of tiles with gaps, the hot restoration technique was chosen. The fact that the owner’s estate is quite vast, is poorly packaged, stored in different places and it is possible to find more fragments of the set, it was considered that this intervention methodology would be the best and least invasive. The panel’s intervention was completed in 2018 and since then it has been possible to recover some more tiles and fragments that have been integrated into the panel (Figure 7, 8 and 9).

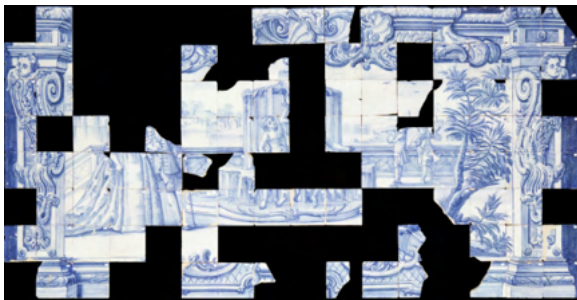
the intervention in “panel 10”, aware that the methodology, in this case, would have to be different from the panel in the Quinta Nova garden. The missing tiles corresponded to about 30% of the total, some of which were just fragments. The missing tile areas corresponded to Figurative elements, such as the characters’ bodies and faces (Figure 5).

Figure 5 – “Panel 10” of Quinta Nova before the intervention.

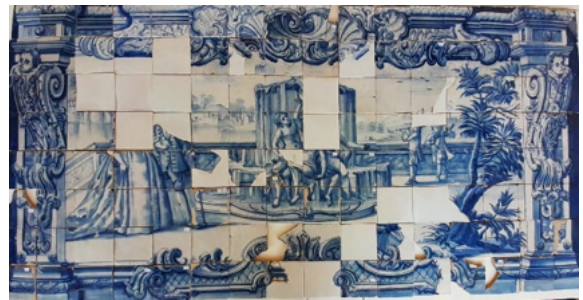
Figure 7 – “Panel 10” of Quinta Nova after some more fragments and tiles were found.

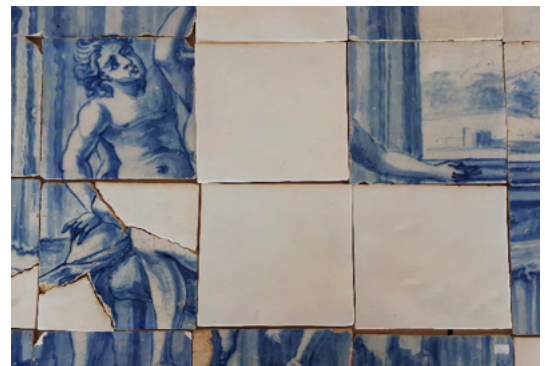
Figure 8 – Detail “Panel 10” of Quinta Nova after the intervention.

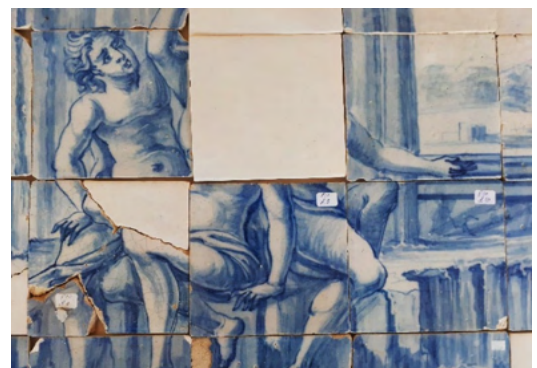
Figure 9 – Detail “Panel 10” of Quinta Nova after some more fragments and tiles were found.

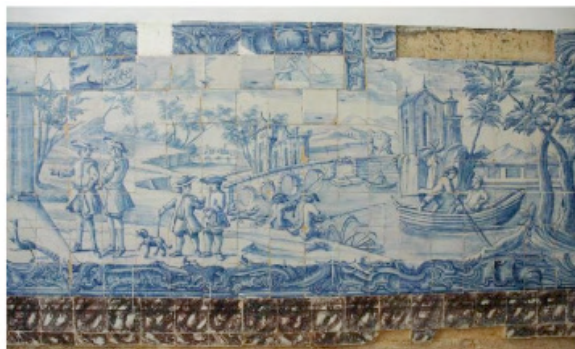
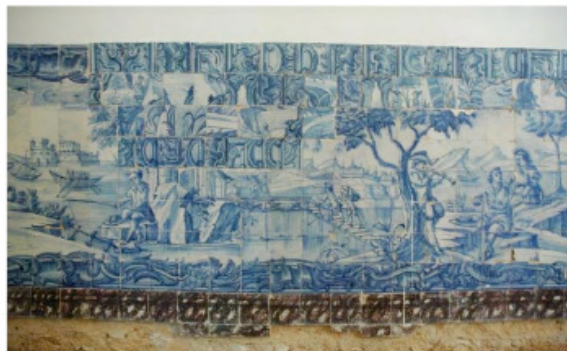
Figure 10 - General appearance of the panels before the intervention.

Figure 11 - General appearance of the panels before the intervention. One of the main problems observed corresponded to the disturbance in the reading of the scenes caused by the use of changed tiles..

The intervention carried out in the chapel began with the resolution of problems at the level of the roof and later extended to the integrated heritage, namely the altarpiece and the ashlar of tiles. The main problems identified were associated with the support or laying mortars. Several areas of plaster affected by the crystallization of soluble salts (efflorescence) were visible, being also visible on the tiles, accompanied by the occasional detachment of glaze in the joint areas. Part of the tiles had poor adhesion to the support, which could cause them to fall as a result of a simple mechanical stress. Another problem that compromised the reading of the set was the use of tiles on the panel out of their original position.

The intervention for the conservation and restoration of the panels, carried out in situ, aimed to respond to the main problems identified: poor reading due to changed tiles; loss of glaze by crystallization of soluble salts; missing tiles; and risk of part of the tiles falling. The intervention had the presence of a permanent team on site that was complemented weekly with the participation of master's students in the tile specialty.

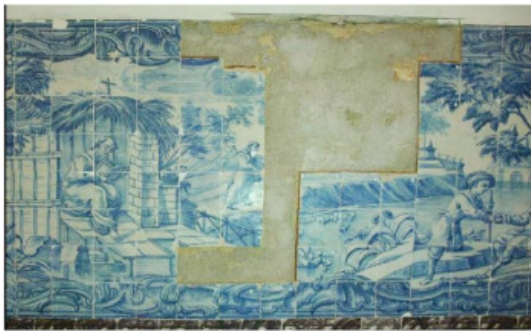
Figure 12 – Wall prepared to receive the new tiles.

related to the fact that the conservation and restoration intervention proposed to solve a problem of reading the panel, without a reference to it. Expectations within the community about the global intervention in the chapel were high. This fact generated some discussion about the criteria to be adopted in this specific case. We opted for the production of new tiles, based on the principle that one of the missing areas corresponded to the frame and that it was symmetrical. The remaining areas of gaps were also filled in with new tiles, suggesting only a few lines of continuity in the design and leaving some areas in the shade of the glaze. This solution allowed the panel to be read back, albeit partially and adopting a different shade of blue, lighter, the intervention being obvious (Figures 12 and 13).

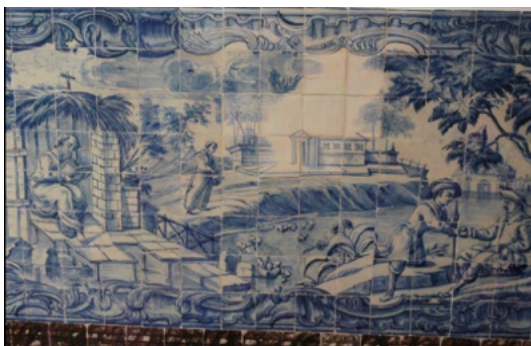
Figure 13 Panel after application of new tiles and reintegration.
