## REHABILITATION OF CORRODED PIPELINES THROUGH PRESSURE- CONTAINING SLEEVES REPAIR

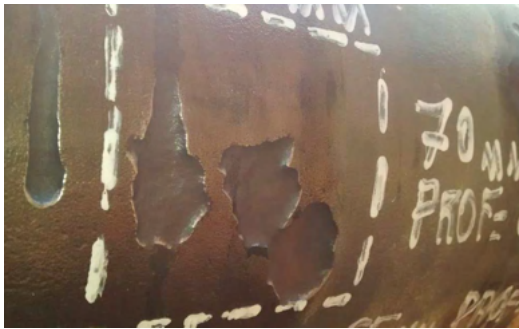
Figure 2 – Photographs of the pipeline after trenching for validation: a) corrosion pits in the most critical region, b) measurement of the pit depth – 6 mm [8].

instrumented pig, of the MFL type (Magnetic Flux Leakage Pig) [7]. Table 1 shows the main design data for the pipeline. In turn, in Figure 2, you can see photographs taken during the field validation for the defect reported in the inspection. It can also be seen in Figure 2.b that corrosion sockets with a depth of up to 6.0 mm were identified on the external surface of the pipeline, when its nominal wall thickness was 7.9 mm.

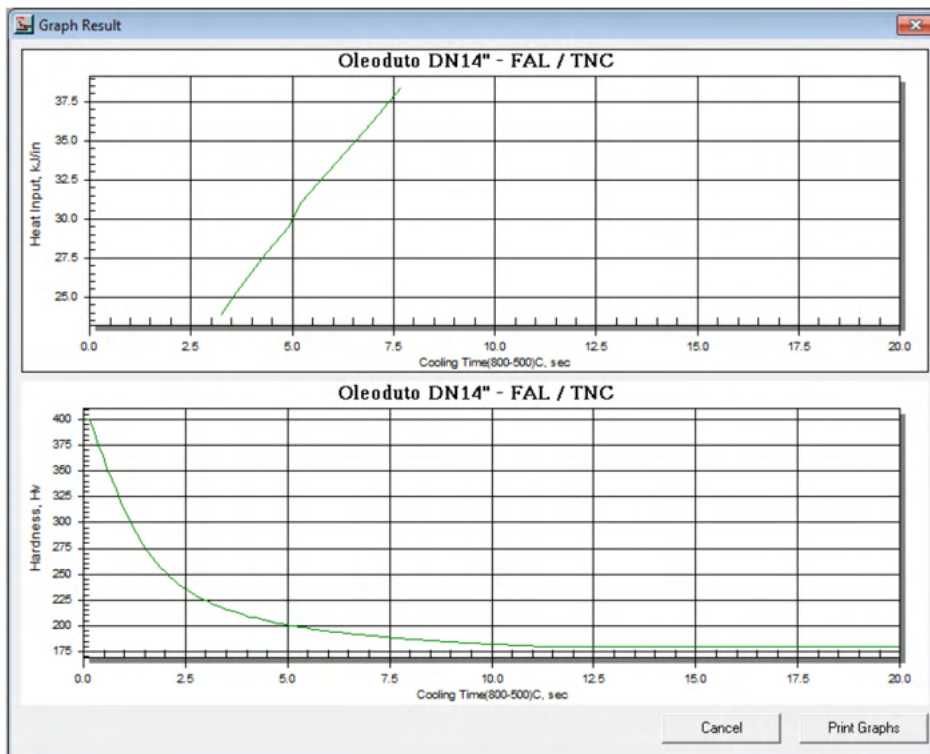
Figure 3 – Welding Energy and Hardness Curves from PRCI software [8].

In the thermal simulation, according to Table 2, a maximum temperature on the inner surface of the pipeline wall of 659 °C and a maximum hardness in the HAZ of 224.96 Vickers were obtained. The software also generated the curves illustrated in Figure 3.

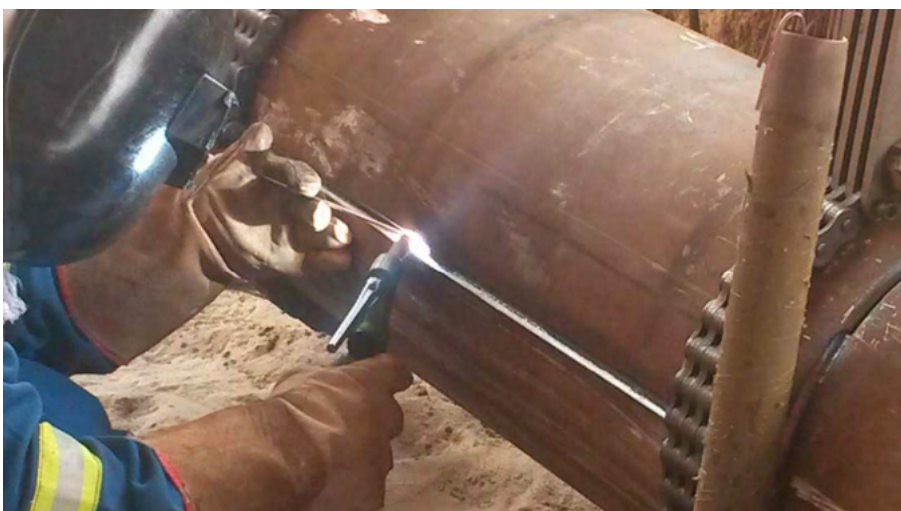
Figure 4 – Longitudinal welding of the root pass for the installation of the pressure-containing sleeves using the GTAW process – Gas-Shielded Tungsten Arc Welding [8].

In Figure 4, there is a photographic record of the moment when the longitudinal weld was performed for the installation of pressure-containing sleeves. As foreseen in the EPS, the root pass was carried out using the GTAW – Gas-Shielded Tungsten Arc Welding process.

The filling passes were performed with a coated electrode (SMAW – *Shielded Metal Arc Welding*).
