ANALYSIS OF THE MECHANICAL PROPERTIES OF *PELTOPHORUM* *VOGELIANUM* POST- ACTUAL FIRE

Abstract: The present work analyzed pieces of wood from the roof structure of a house that suffered a fire in the city of Itapeva, in the interior of São Paulo. The roof structure was built 25 years ago using wooden beams from the Guaruaia species (*Peltophorum vogelianum*). In general, the surface layer of coal formed in the structural elements subjected to fire preserved the mechanical properties of the core. The values of shear strength (f_v), compressive strength (f_{c0}) and modulus of elasticity (E_{c0}) in compression parallel to the fibers for this species with an average density of 919 kg/m^3 , according to the Brazilian standard NBR 7190/97, are 15.5 MPa, 62.4 MPa, and 17212 MPa, respectively. In the tests carried out, the twelve specimens analyzed had values close to and even higher than the normalized ones. With an average density of $815 \pm 58 \text{ kg/m}^3$, the samples had values of $14.8 \pm 3.0 \text{ MPa}$ for shear strength (f_v), $62.6 \pm 11.0 \text{ MPa}$ for strength values (f_{c0}) and $21751 \pm 8230 \text{ MPa}$ for the modulus of elasticity (E_{c0}) in compression par

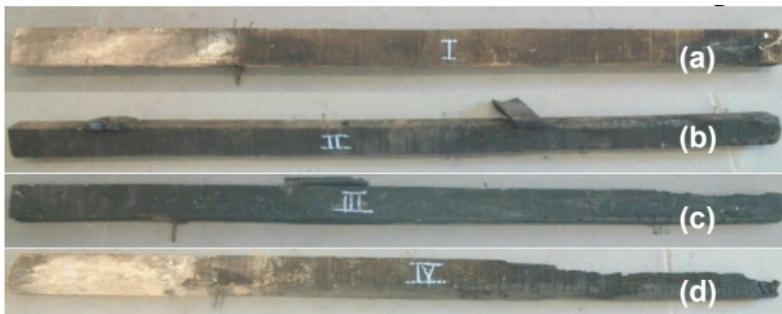
Figure 3: Parts removed from the roof structure that went through the fire.

To carry out this work, wood species from a real fire occurred in the rural area of the municipality of Itapeva/SP were used. The parts were obtained one week after the accident, when four rafters of nominal cross-section of 60 x 50 mm and 1.30 meters in length were collected from the structure of the burned roof (Figure 3).
