## USE OF UNMANNED AIRCRAFT (DRONES) FOR THE INSPECTION OF ARCHITECTURAL MONUMENTS AND ANCIENT CONSTRUCTIONS

*Rubén Rodríguez Elizalde*

**Keywords:** Drones, Heritage, Roman Bridge, Inspection, Heritage Conservation.

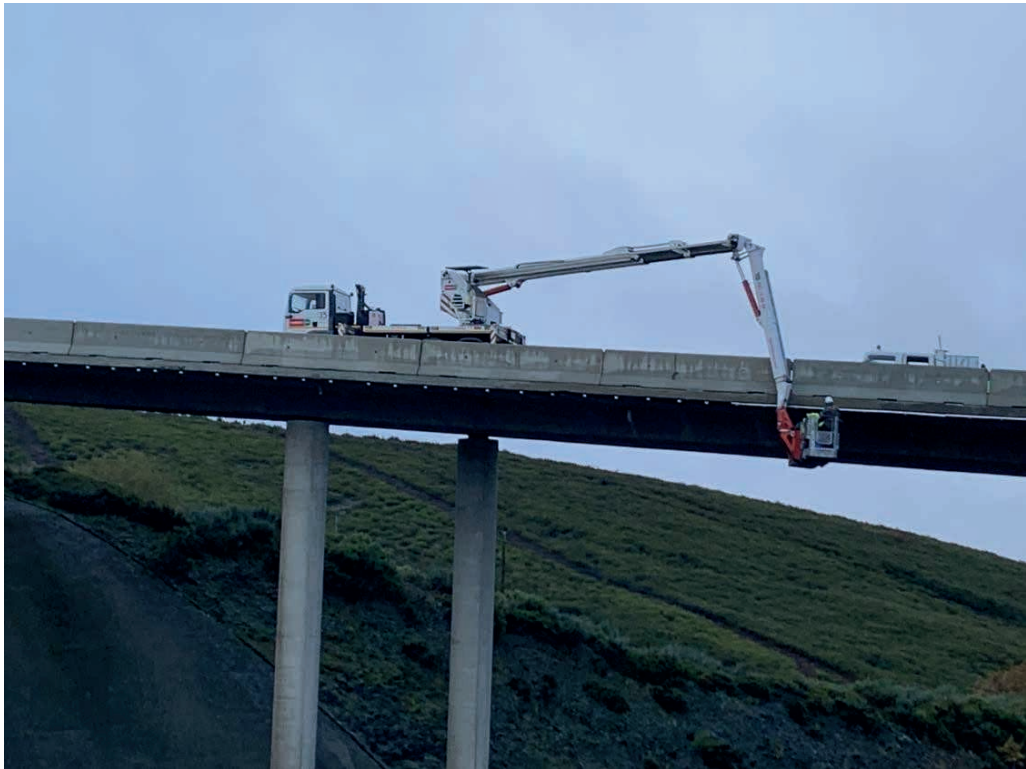
Figure 1: Inspection of the deck of a viaduct that crosses the Rías Bajas Highway (A – 52), near the municipality of A Gudiña, in the province of Ourense (photograph by the author).

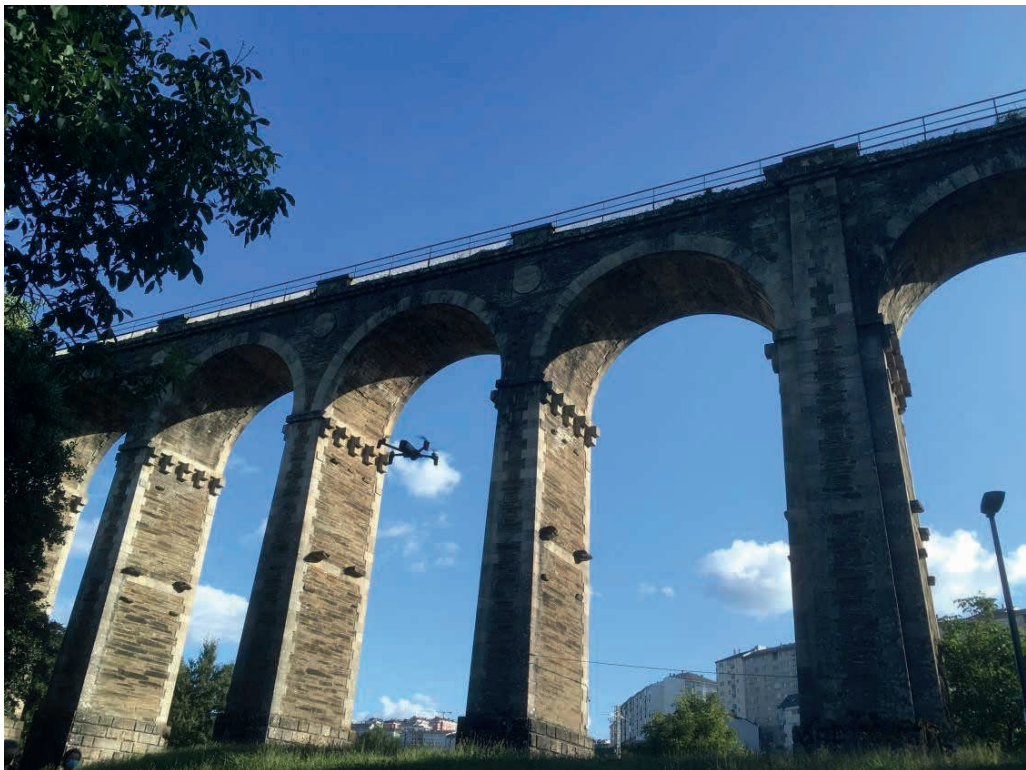
Figure 2: Quadcopter drone approaching for an inspection over the Ponte da Chanca, a railway viaduct located in the city of Lugo that celebrated its 150th anniversary on December 20, 2021 (photograph by the author).

multirotor (Figure 2): they are drones with multiple propellers (always pairs) that take off vertically and have, In addition, the ability to rotate on themselves, which makes them ideal for doing vertical work and maintaining a certain fixed position while suspended in the air, thus allowing accurate analysis.

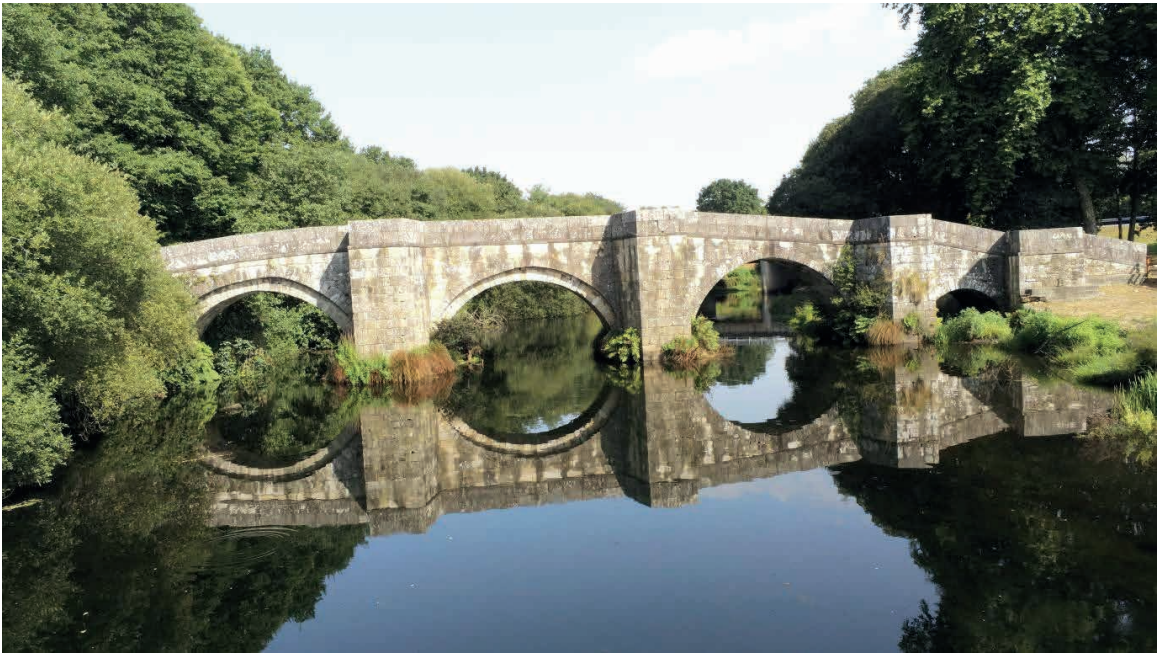
The Bridge has four ashlar arches (Figure 3): three of them with the same span (8.20 meters), and the last one, at the southern end of the bridge, with a considerably smaller span (4.30 meters). The piles, with tamajares that go up to the crest (Figure 5), are very thick, around 3.00 meters. The two vaults on the right margin (Figure 3 and Figure 4) have a double thread. Both the vaults and the eardrums and parapets are made of ashlar masonry (Alcaide & López, 2013). Due to its characteristics, both constructive and aesthetic, the date of

Figure 3: General view of the elevation downstream of the Brandomil Bridge, in an image captured with the multi-rotor drone used in the inspection of this article (photograph by the author).

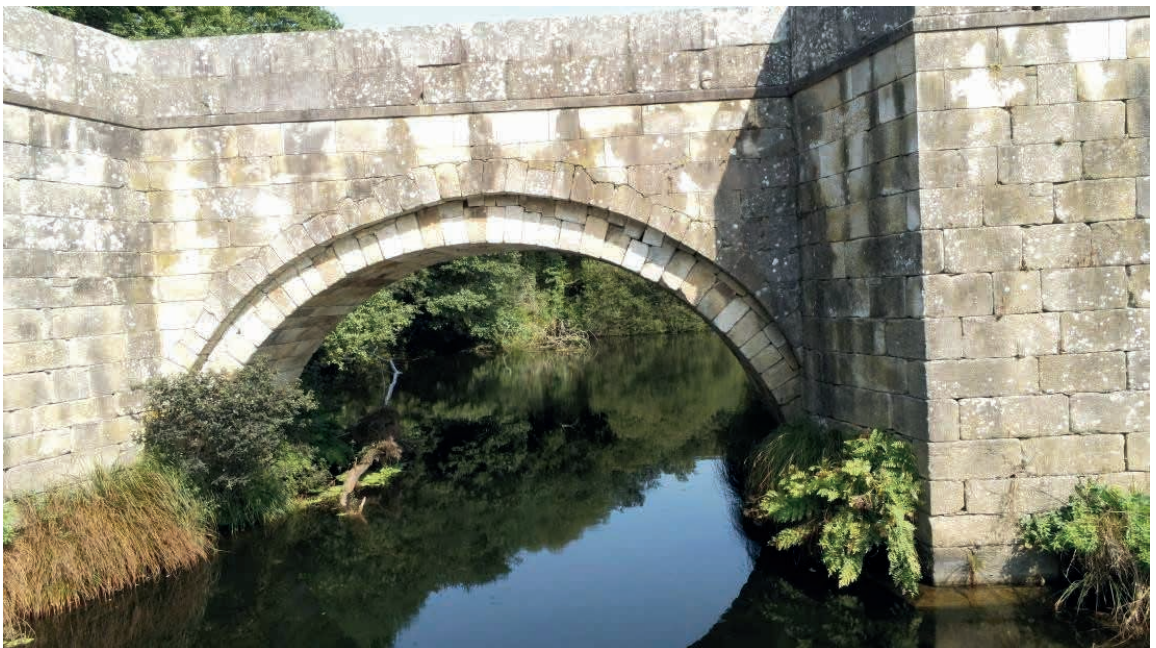
Figure 4: General view of one of the major arches of the Brandomil Bridge, in an image captured with the multi-rotor drone used in the inspection from the downstream side of the Bridge (photograph by the author).

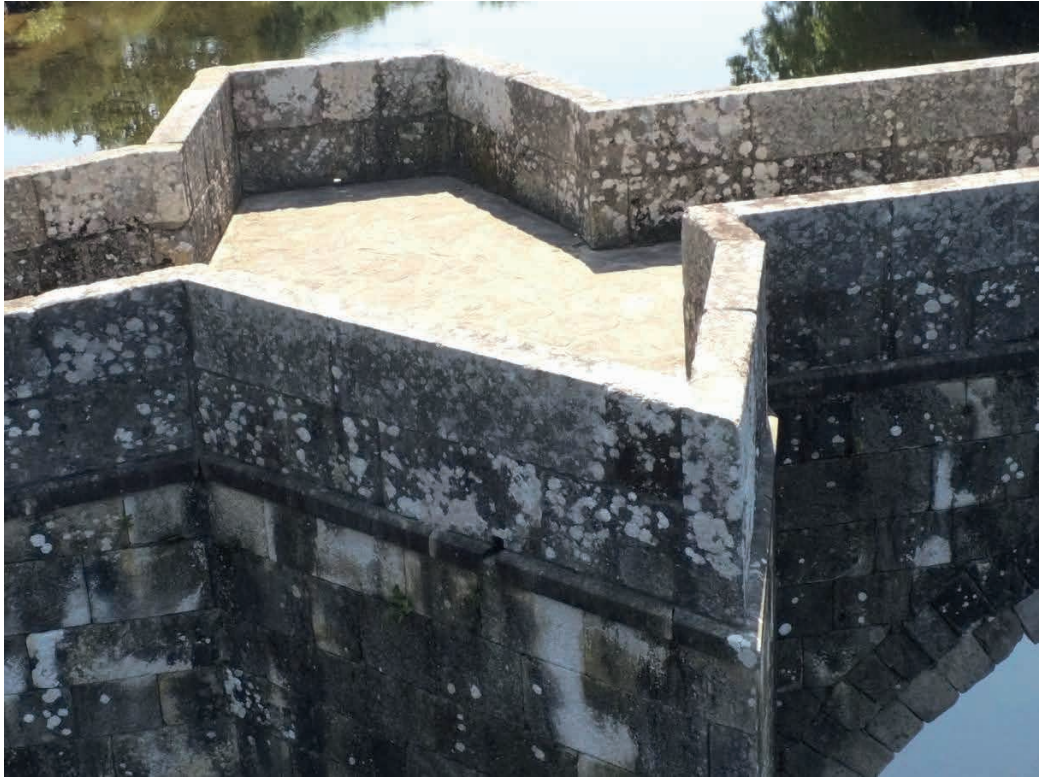
Figure 5: General view of the upper part of one of the cutwaters of the Brandomil Bridge, in an image captured with the multi-rotor drone used in the inspection (photograph by the author).

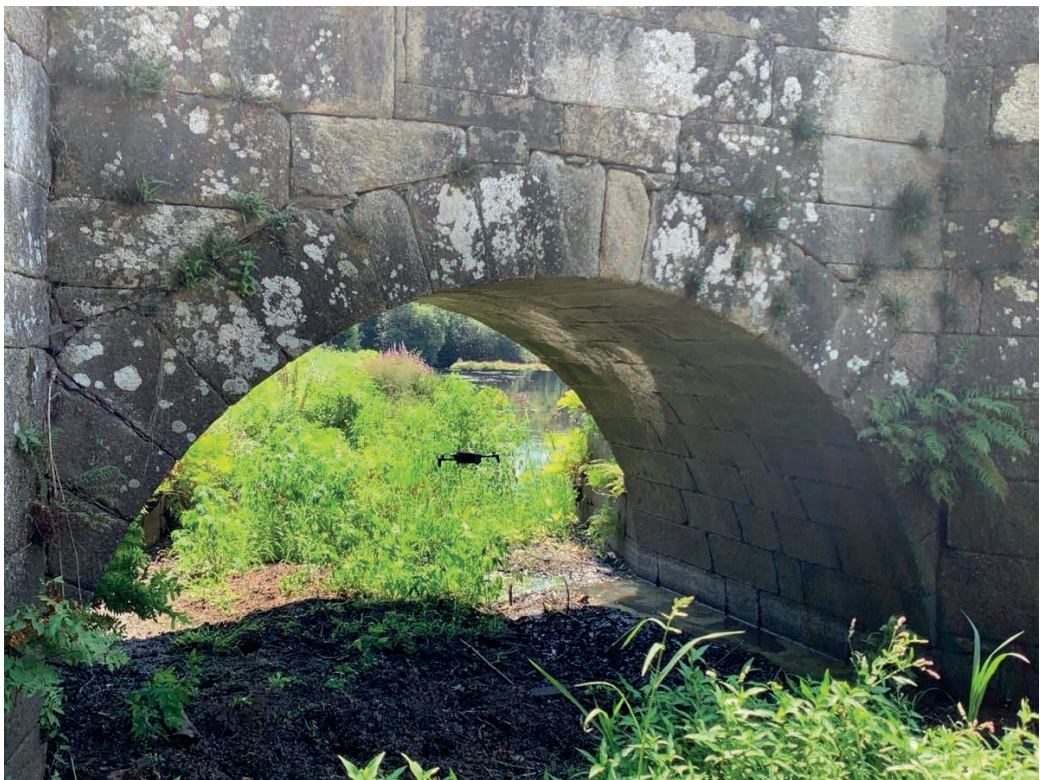
In the previous images you can see the four-propeller drone used, analyzing in suspension the interior of the smaller vault of the Bridge (Figure 6) and approaching one of the larger vaults over the course of the river for recognition (Figure 7). The equipment incorporated a high-resolution camera with zoom and allowed the capture of the images that are collected later, which could constitute a complete photographic report with the most outstanding observations during the flight.

In addition, it must be taken into account that one of the hallmarks of this bridge is the use of the minor semicircular arch as a guideline for its vaults, as opposed to the common Roman use of the arch. Given the scant arrow of the smallest vault, access to its interior to analyze the state of the intrados was somewhat complicated (Figure 6), hence

Figure 6: Multi-rotor drone used in the inspection of the Brandomil Bridge, entering the interior of the vault of the minor arch for inspection from the upstream side of the Bridge (photograph by the author).

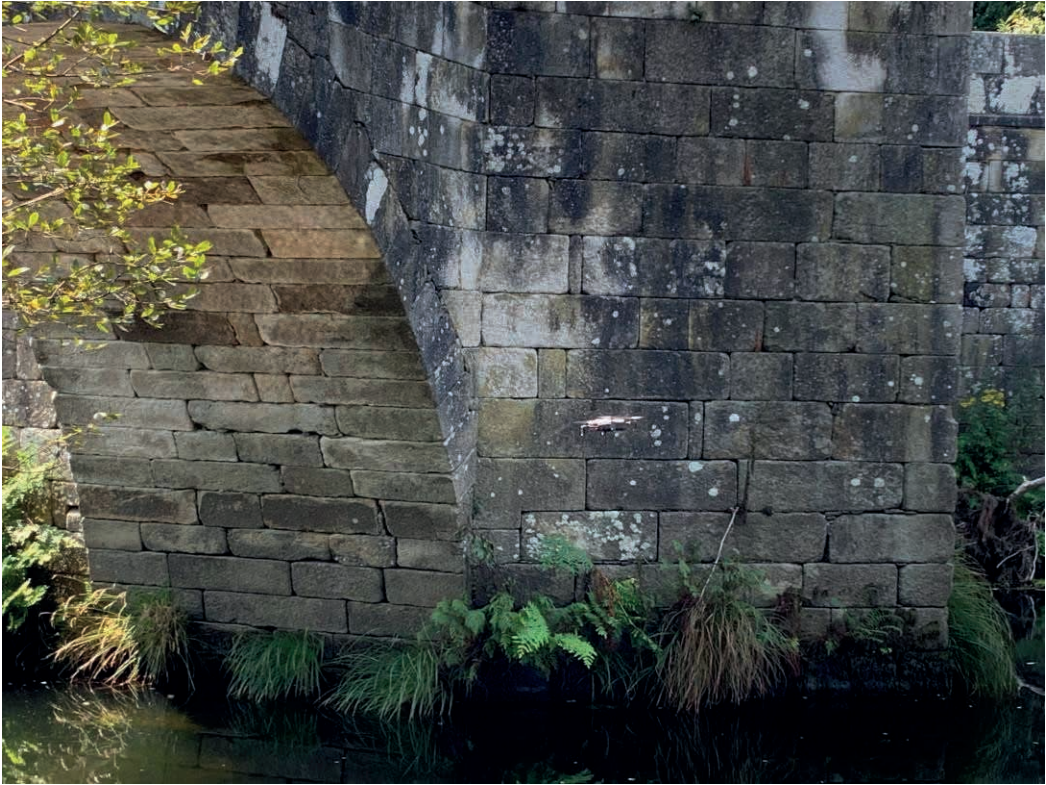
Figure 7: Multi-rotor drone used in the inspection of the Brandomil Bridge, approaching the upstream elevation of the Bridge, for the inspection of various constituent elements (photograph by the author).

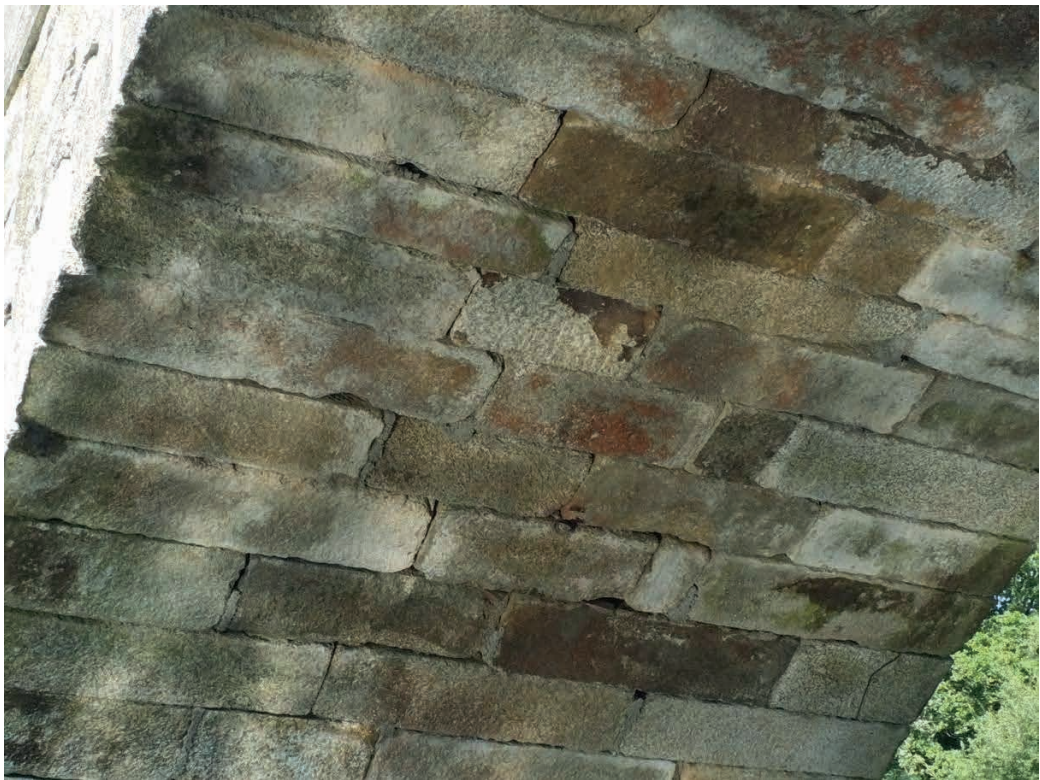
Figure 8: General view of the downstream elevation of the Brandomil Bridge, in an image captured with the multi-rotor drone used in the inspection of this article (photograph by the author).

The granite constituting the monument presents, inside the vaults, certain deteriorations as a consequence of the synergy of actions of a diverse nature, fundamentally chemical and biological. Thus, the formation of various black crusts can be observed (Figure 8), presumably linked to the action of polluting agents (particularly sulfur

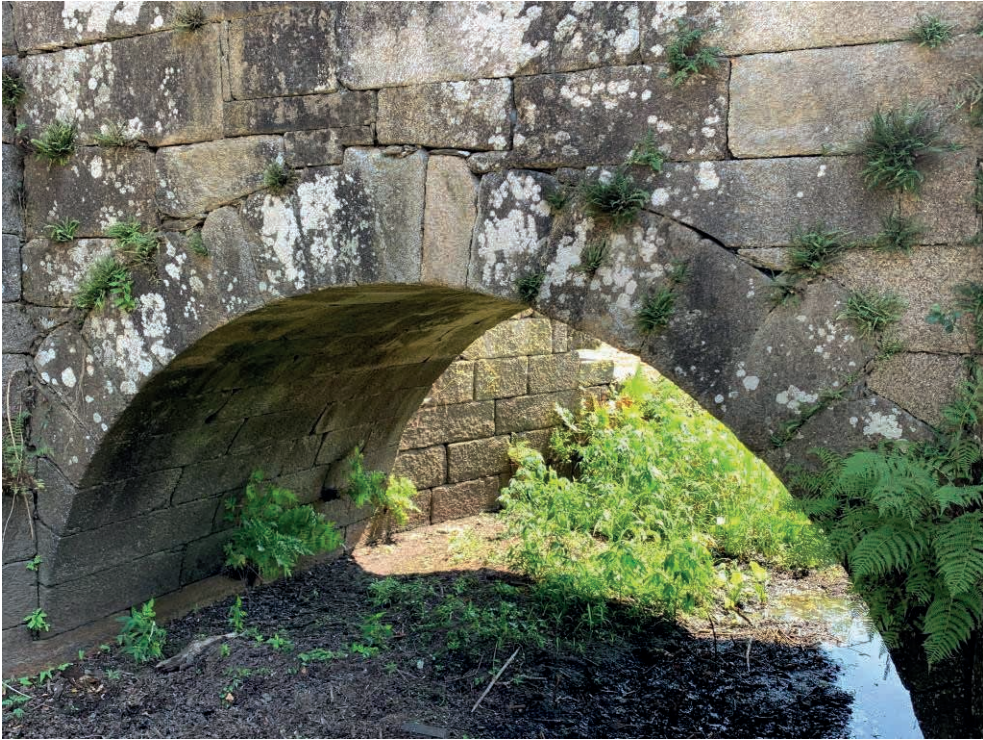
compounds). Along with these crusts, there is an abundant presence of biocolonies (plants), which have grown rooting in the joints that are arranged between the ashlar, especially in the joints of angular points (Figure 9 and Figure 10), which enter into feedback with the phenomena of humidity, efflorescence and runoff water, as reflected in certain observed spots.

This section is closed, repeating the presence of rooted vegetation in the joints between the ashlar (Figure 9 and Figure 10). Due to the humidity, and given the susceptibility of the granite to attack of a biological nature, the drone was also able to record films or mottles, resulting from the accumulation of plant microorganisms, moss-like or similar (Figure 9 and Figure 10).

Figure 9: General view of the smaller arch of the Brandomil Bridge, seen from the upstream side, in an image captured with the multi-rotor drone used in the inspection, where the abundant presence of rooted vegetation can be observed in the multiple elements (photograph by the author).

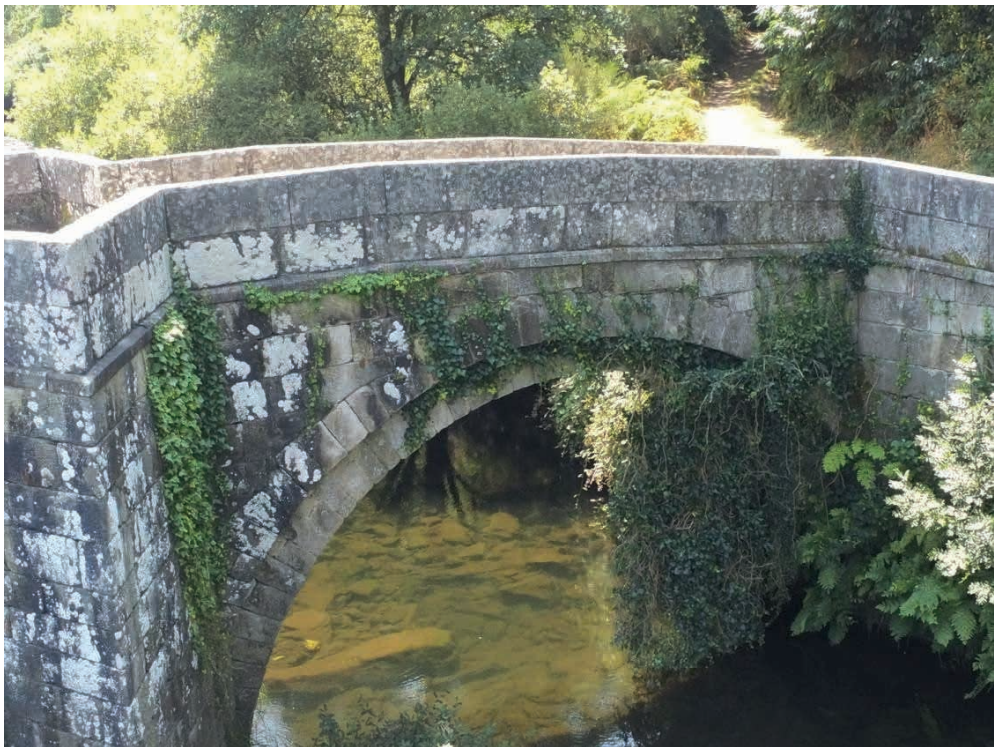
Figure 10: General view of one of the major arches of the Brandomil Bridge, seen from the upstream side, in an image captured with the multi-rotor drone used in the inspection, where the abundant presence of rooted vegetation can be observed in the multiple elements (photograph by author).
