Journal of Engineering Research

ENGINEERING SKILLS AID BY THERMOGRAPHY AND BIM

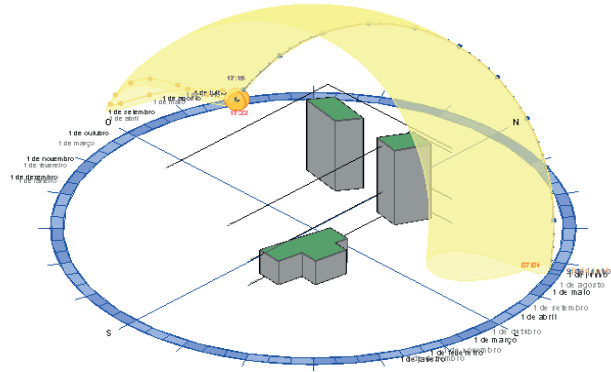
Figure 1: Solar chart in the software interface

Figure 1 illustrates the virtual simulation of the solar chart of a building (mass of smaller volume) and its surroundings (mass of larger volume) on July 1st, at 5:22 pm. Once the time is fixed on the celestial dome, the parametric software allows the sun to move to different positions, along the infinity-shaped trajectory (yellow color), simulating the Earth's translational movement. As the sun moves throughout the twelve months of the year, the software interface becomes dynamic and for this reason, on one side of the circumference

the months are actively indicated (black color) and, on the other, passively (gray color).

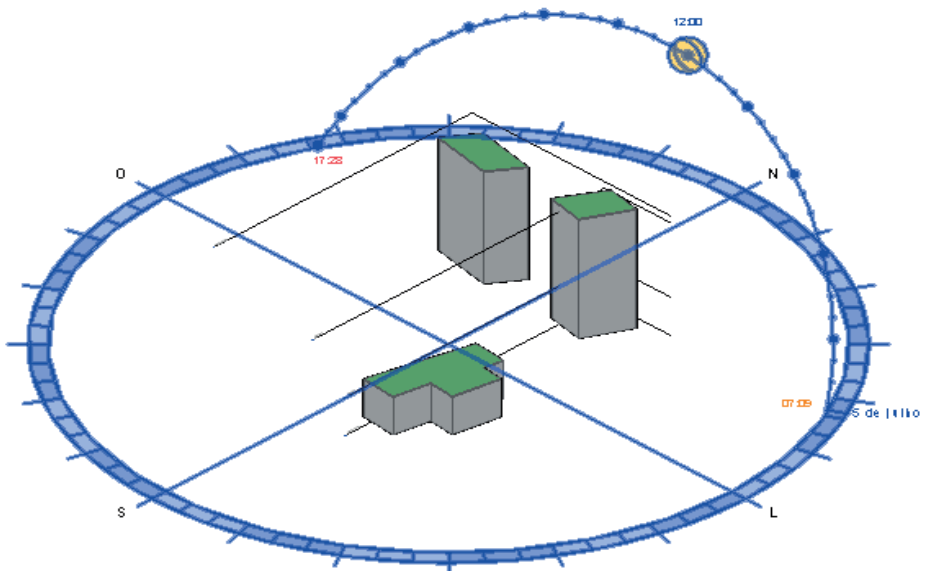
Figure 2: Solar chart

Due to the hospital use of the building, it was decided to apply the passive qualitative thermographic technique. The inspection took place during the winter solstice of the southern hemisphere, between July 4th and 6th. Figure 2 illustrates the Revit software interface and the simulation of the solar chart at the latitude of the study object, on July 5th at 12:00 pm (expertise start time) and the sunrise and sunset times at 07:09h and 17:28h, respectively.

The mass models of the inspected building and its surroundings allowed the simulation of the effects caused by solar radiation and, consequently, the shading of the facades of the inspected building. In this sense, it assisted in the analysis of the records collected linked to the georeferencing of the object of study (north, south, east and west facades).

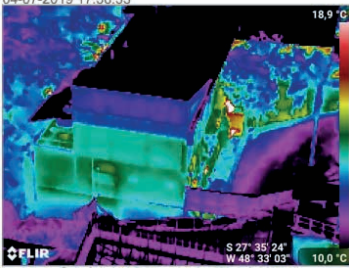
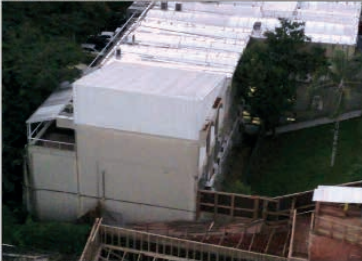
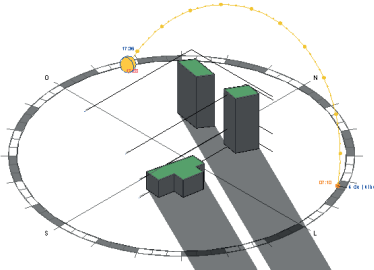
In the thermal record of the south facade (17:36h) the structural typology of the reinforced concrete building (pillars and

beams) can be seen. It can be seen that the roof of the building had a lower temperature record than other points, however this is a reflective response due to the high reflection rate of the tile material.

<p>18,9 °C</p> <p>S 27° 35' 24" W 48° 33' 03"</p> <p>10,0 °C</p> <p>FLIR</p> <p>South facade</p>	<p>04-07-2019 17:36:33</p>

<p>Latitude: S 27° 35' 24", Longitude: W 48° 33' 03"</p>

<p>07/04 at 5:36 p.m.</p>
<p>04-07-2019 17:15:46</p>

Table 1 presents the thermographic and respective photographic records of the south, west and east facades of the building, in addition to the internal and external slabs. The thermal recording times were parameterized in the architectural modeling software, enabling the simulation of the sun's path at the exact moment of capture, revealing the shading effects of the immediate surroundings.

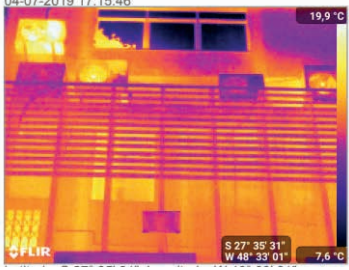
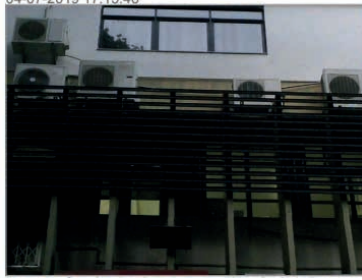
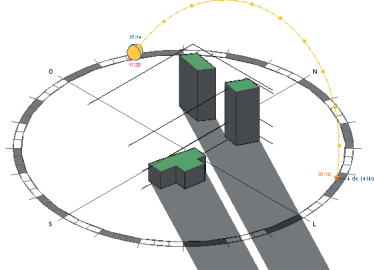
On the west facade (5:15 pm) it is possible to identify the existence of structural parts (pillars) in the vertical fence system and, on the east facade (8:00 pm) it was possible to characterize the typology of the traditional vertical fence (ceramic bricks).

<p>19,9 °C</p> <p>S 27° 35' 31" W 48° 33' 01"</p> <p>7,6 °C</p> <p>FLIR</p> <p>West facade</p>	<p>04-07-2019 17:15:46</p>

<p>04/07 at 17:14h</p>
<p>06-07-2019 20:00:45</p>

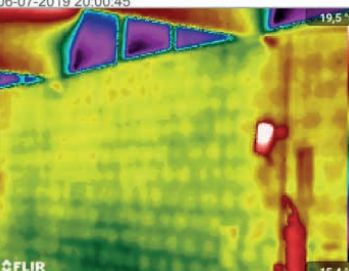
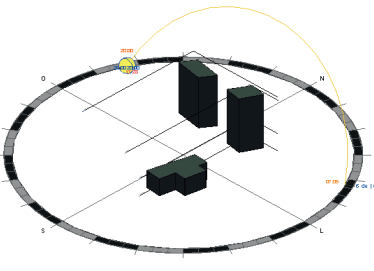
<p>19,5 °C</p> <p>15,4 °C</p> <p>FLIR</p> <p>East facade</p>	<p>06-07-2019 20:00:45</p>

<p>06/07 at 8:00 p.m.</p>
<p>05-07-2019 18:53:14</p>

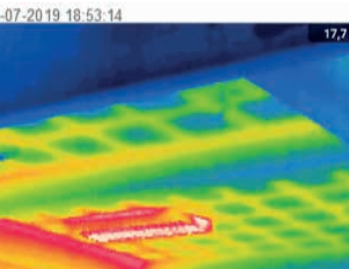
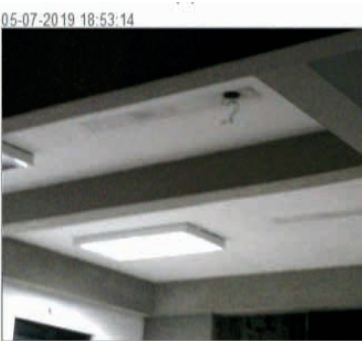
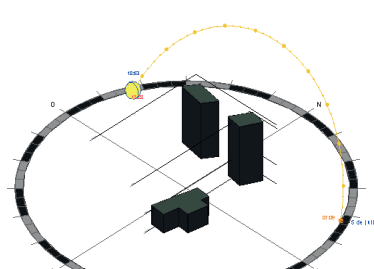
The recording of the external slab (18:53h) revealed greater clarity of the hidden elements present in the structure, which is justified by the incidence of solar radiation during the day and the drop in temperature in the external environment at night, thus creating thermal contrast ideal for thermographic recording. The recording of the internal slab (7:19 pm) was made possible by completely eliminating the artificial light in the environment, which, due to the controlled air conditioning required in the hospital environment (21 degrees Celsius), made any contrast impossible.

<p>17,7 °C</p> <p>13,6 °C</p> <p>FLIR</p> <p>External slab</p>	<p>05-07-2019 18:53:14</p>

<p>07/05 at 6:53 p.m.</p>
