STUDY OF LEAK INTERFERENCE FROM THE RIO MADEIRA THERMOELECTRIC PLANT IN THE WELLS OF BAIRRO NACIONAL - PORTO VELHO/RO

Keywords: Groundwater, contamination, petroleum products, thermoelectric plant.

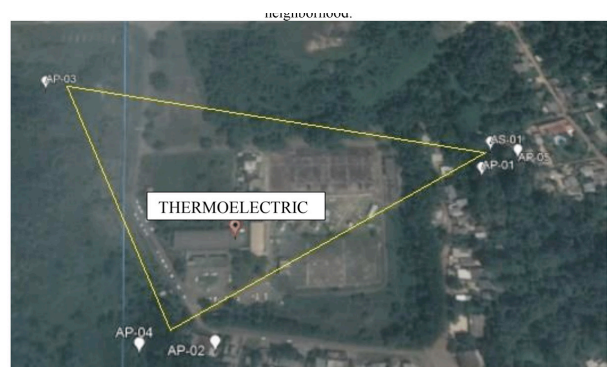
Figure 3 shows the location of the collection points, named as follows:

AS-1 - Surface Water from collection point1

AP-1- Well water from collection point 1

AP-2 - Well water from collection point 2

AP-3 - Well water from collection point 3

AP-4 - Well water from collection point 4

AP-5 - Well water from collection point 5

Figure 03. Rio Madeira Thermoelectric Plant in the Nacional neighborhood.

from nearby points is due to the local geomorphological difference, for example we have the AP-04 and AP-02 collection points, the AP-02 collection point is located at a higher altitude, making it Therefore, upstream of point AP-04, this choice was made in order to identify the possible percolation of the polluting fluid to higher locations. The same line of reasoning was adopted for points AP-01 and AP-05, considering point AP-01 upstream and point AP-05 downstream of the contamination.

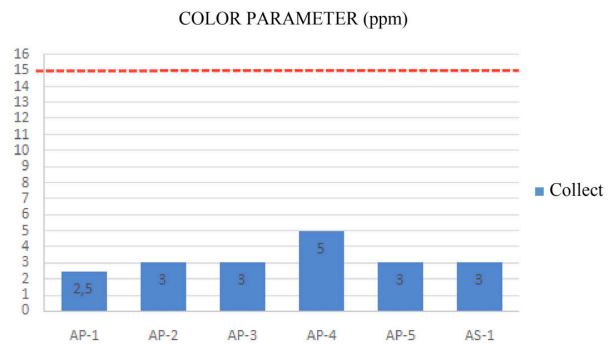
Color is an aesthetic parameter of acceptance or rejection of the analyzed water, which aims to indicate the presence of substances dissolved in the water. According to Ordinance 2914/11 of the Ministry of Health, the maximum permissible color value in distributed water is 15.0 U.C. Therefore, all water samples analyzed are within the range indicated by current legislation, indicating an acceptable presence of organic matter or metals as shown in figure 5 below.

Figure 05. Limit range of the color parameter as predicted by conama and the respective results obtained.

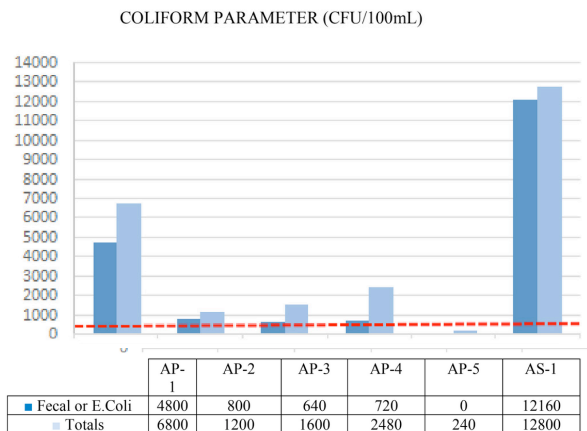
Figure 07. Graph of microbiological analysis results

Of the total of 6 samples collected, all showed a large load of heterotrophic bacteria except sample AP-05, where there was no detection of fecal coliforms or *E. coli*, however, in all samples, contamination by total coliforms was detected. Ordinance Number: 2,914/2011 establishes the microbiological standard of water for human consumption and determines the absence of positivity for total coliforms and *Escherichia coli* per 100

mL of water samples analyzed. Therefore, with regard to microbiological analyzes, the water from these wells cannot be considered drinkable, according to Ordinance Number: 15 2914, of December 2011 (MS), since high values of fecal and total coliforms were detected. in all samples analyzed, exceeding the values set out in current legislation, as mentioned above.

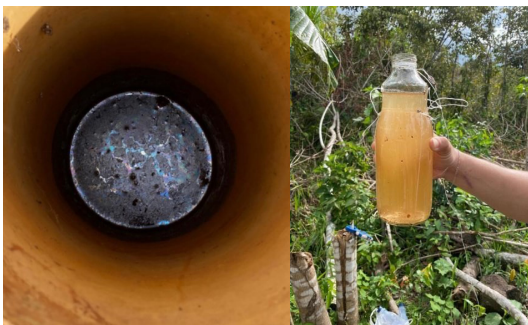
As can be seen, the water samples analyzed presented values below the maximum limit of CONAMA resolution N°396, dated April 2008. However, concentrations of BTEX compounds were detected in all samples. Such results lead to the understanding that the situation regarding water contamination is not worrying, from an analytical point of view, however it is possible to visually identify a large presence of oils or greases on the surface of the water in the collection sites, as shown in figure 8, this presence of surface oils or grease prevents the entry of light and oxygen into the water, which can cause the death of aquatic species since their development and survival depend on sunlight. Correct inspection by the federal government and the responsible state agencies and continuous monitoring of pollution are extremely important to guarantee the integrity of the local environment, since the contamination under study by the Public Ministry was confirmed in 2020.

Figure 08. Visual detection of the presence of oil or grease on the surface of the collected samples.
