## CASE STUDY: ANALYSIS OF PATHOLOGICAL MANIFESTATIONS FOUND IN THE GARAGE AREA OF A BUILDING IN ARMED CONCRETE LOCATED IN THE CITY OF RECIFE-PE

*Felipe Vasconcelos*

IPOG – Graduate and Graduate Institute  
Goiânia, GO, Brazil  
0000-0003-0869-7570

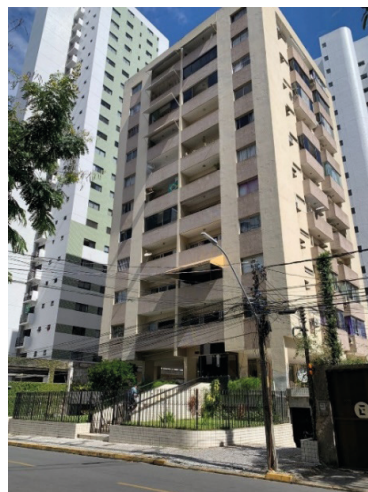
Figure 4 – Front view of the building under study

It consists of a tower with 12 floors, 10 of which are apartments (2 per floor), a pilotis and a semi-underground garage floor. In total, the building has 20 residential apartments, where each apartment has 123 m<sup>2</sup> of private area.

The building is more than 50 years old and there has been almost no preventive maintenance during all this time. Due to this, the building has been suffering from various pathologies on practically all floors. According to reports from residents, a company was hired to make a specialized technical report for the entire building and the necessary structural repairs have already been started in some parts of the pilotis area.
