Scientific Journal of Applied Social and Clinical Science

HISTORICAL ANALYSIS AND GENERAL STATE OF CONSERVATION OF THE MARIETA TEIXEIRA DE CARVALHO MANSION, SÃO PAULO

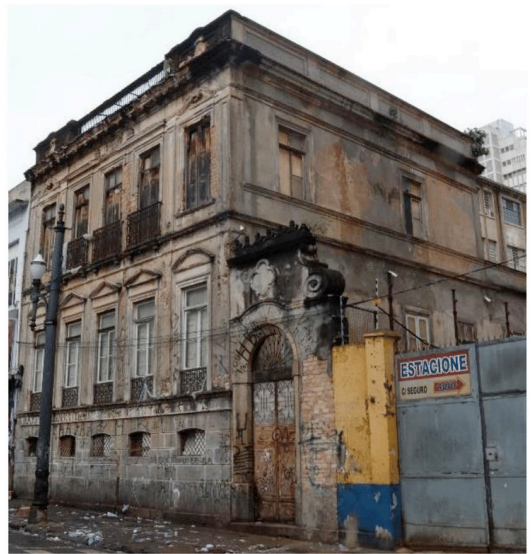
Figure 1: Perspective view of the Palace with the side gate leading to the garden and garage

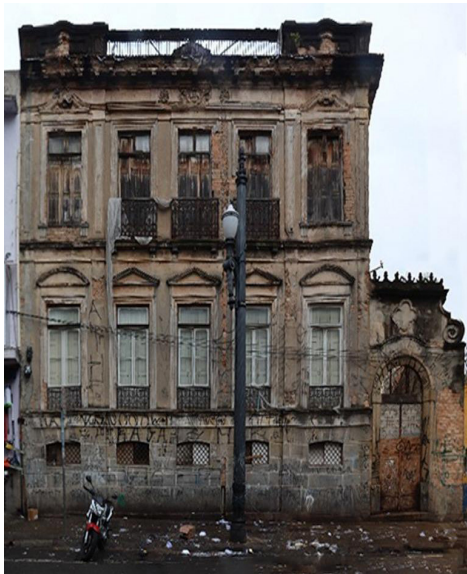
The front facade, which is the main object of study in this work, still retains the beauty and grandeur of its original construction, but shows serious wear caused mainly by lack of maintenance. The plaster is peeling off in several parts and you can see the exposed bricks. It was from this location that the sample was taken to test the mortar used to lay the mortar and perform the plastering (Figure 4).

Figure 5: Photographic mosaic of the mansion's facade for the production of the Damage Map
