Journal of Engineering Research

USE OF UNMANNED AERIAL VEHICLES (DRONES) FOR THE AUSCULTATION OF HISTORIC ARCHITECTURAL FEATURES AND ANCIENT STRUCTURES

Rubén Rodríguez Elizalde

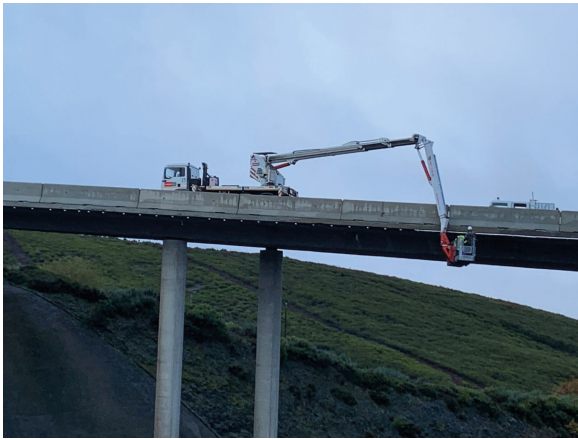
Figure 1 - Inspection of the deck of a viaduct that crosses the Rías Bajas Highway (A-52), at the height of the municipality of A Gudiña, in the province of Ourense (photo by the author).

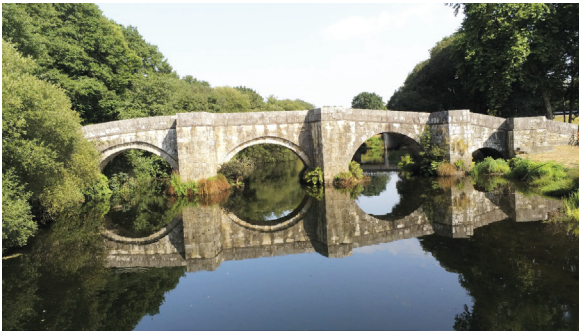
The bridge has four ashlar arches (Figure 3): three of them with the same span (8.20 meters), and the last one, at the south end of the bridge, with a considerably smaller span (4.30 meters). The piers, with sills rising to the crown (Figure 5), are very thick, about 3.00 meters. The two vaults on the right bank (Figure 3 and Figure 4) have double threads. Both the vaults and the tympanums and parapets are made of ashlar (Alcaide & López, 2013). Due to its characteristics, both constructive and aesthetic, the date of its construction is dated to the 17th century, although there is evidence of the existence of an earlier bridge in this same place (Casado, 1969).

Figure 3 - General view of the downstream elevation of the Bandomil Bridge, in an image captured with the multi-rotor drone used in the inspection of this article (photo by the author).

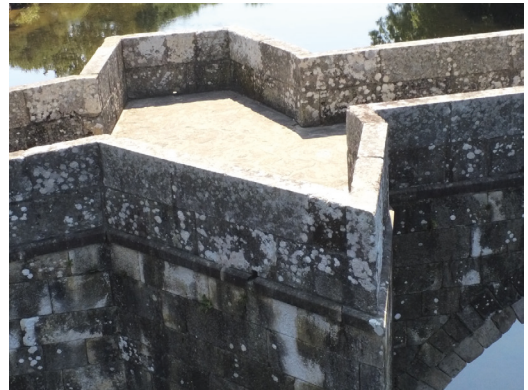
Figure 5 - General view of the upper part of one of the cutwaters of the Bandomil Bridge, in an image captured with the multi-rotor drone used in the inspection (photo by the author).

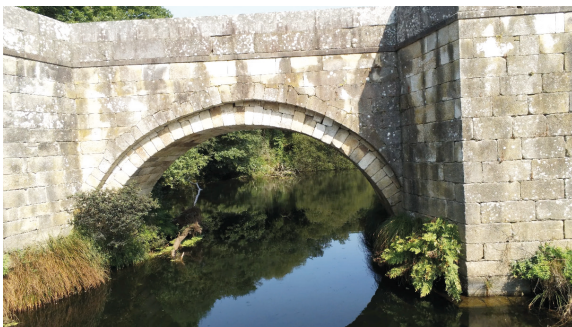
Figure 4 - General view of one of the major arches of the Bandomil Bridge, in image captured with the multi-rotor drone used in the inspection from the downstream side of the bridge (photo by the author).
